Geological Investigation for Environmental Impact Assessment (EIA): Case Studies from Some of Mini Hydropower Projects in Sri Lanka

Nanda Wipula Bandara Balasooriya
balasooriya@seu.ac.lk nanda_balasooriya@yahoo.com

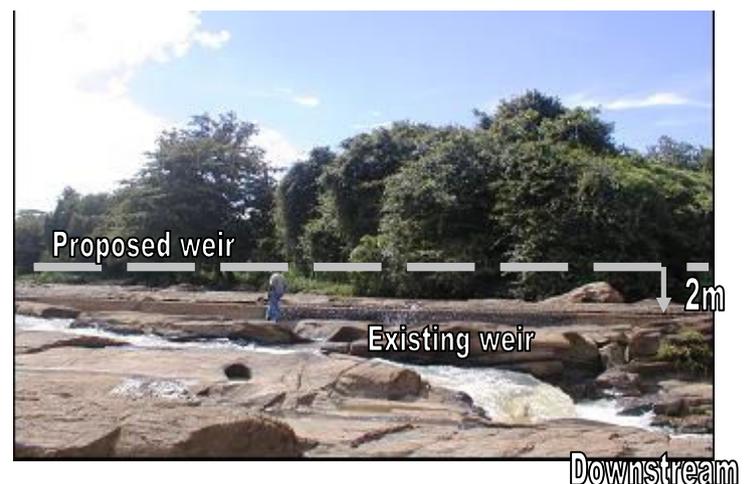
The project area is mainly located along the southerly to northerly strike valley of Sudu Ganga basin. There is an existing weir at the proposed project site which regulates and diverts Sudu Ganga water to irrigate existing agricultural lands located along both banks in Rajjamma and Lihinipitiya villages. Irrigation outlets are available at both ends of the weir to issue water quantifying amount maximum of 0.5 m³/sec for irrigation purposes by each canal. This existing weir will be modified and raised by another 2 m, to have an additional water head for power generation (Photo 1). Length of the weir is 182 m and maximum height is 4 m at the centre part. Weir will be an ogee shape one without spillway gates.

The pool area will be approximately 16 Ha at fsl. The damage for the bank will be minimized when the pool area increases. The riverbanks will be submerged to an additional extent of 2 m and the river will be surged back to a length of approximately 107 m. There will be no substantial increase in the inundation area due to increase in weir height. The separate inlet channel will be constructed 30-40 m away from left side of the weir, under new phase of the proposal. This channel is aligned along the NE-SW oriented mountain which is located at the left bank of the stream.

Photo 1: Proposed weir site and pond area

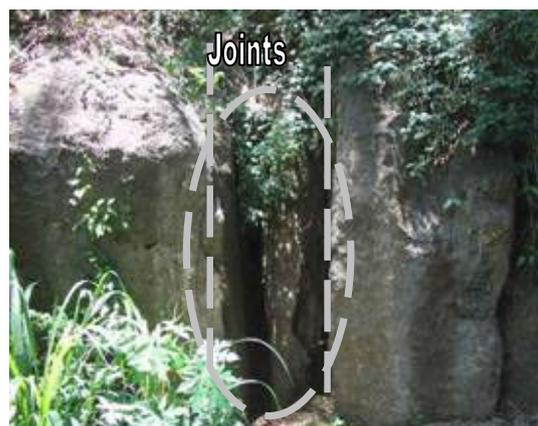
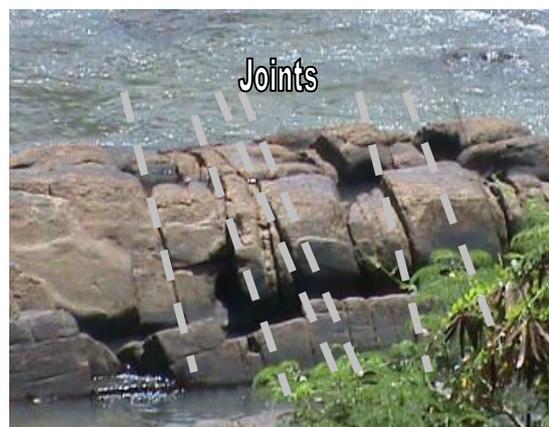
Well foliated bedrock is exposed in the downstream section of the weir. There are major well-defined joints in Garnet biotite gneiss and Biotite gneiss below the channel trace, along the existing irrigation canal (Photo 2).

Photo 2: Well foliated-highly jointed rocks (a) along the channel trace: (b) At the downstream of Sudu ganga
