Study of the causes for a landslide occurring on a national road

Voicu Cristina Otilia, Mirea Monica

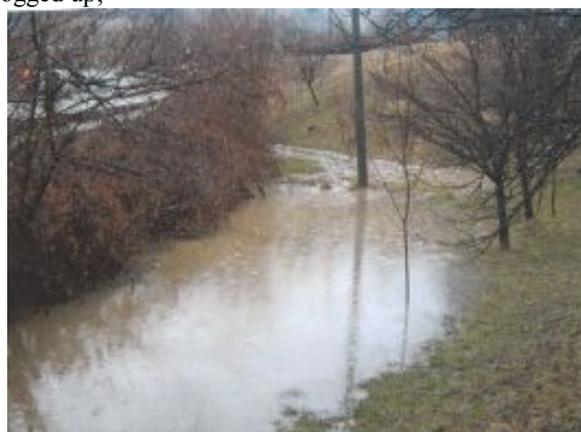
- the presence of a subsidence (Fig. 1) filled with water on the right side of the road (upstream), 15...20 m from the landslide. It did not dispose of any bypass since the culvert supposed to unload the water in this area was completely clogged;

Fig. 1 Swampy soil

Besides the direct infiltration of water in the mountainside, the main source of water alimentation for the earthwork and foundation terrain of the road was the water collected in the aforementioned subsidence, which (as proven above) had no draining conditions.

- unclogging of the existing culvert in the area of the water filled subsidence and the execution of a stone facing ditch, in order to absorb the water from the weepholes;

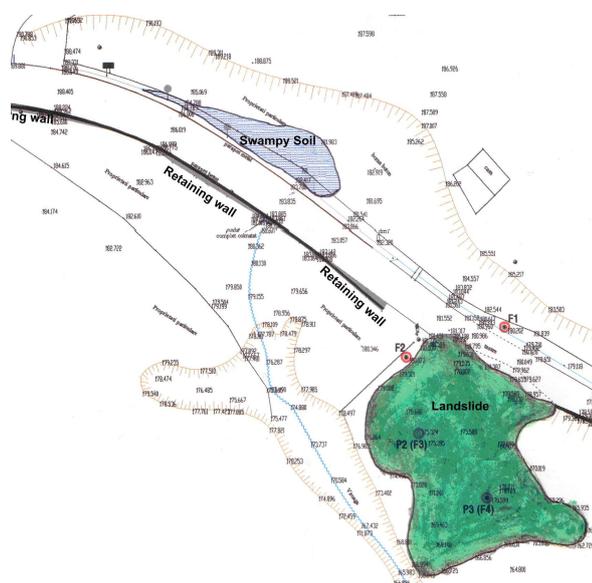
Fig. 2 Site plan with borings and penetration position

Thus, in test boring F_1 (Fig. 2), executed at the level of the roadway, under the vegetal layer, a sandy clay layer was discovered. It relies on a sand stone schist, present in depths of about 2,50 m. In test boring F_3 , executed in the middle part of the landslide's length, the slid mass was signaled on the surface in a depth of 3,5...4,00 m. Because of the deranged structure, it had a filling character and its basis was comprised of sandy dust and sandy clay layers (both plastic consistent). In depths of 5,50...6,00 m a layer composed of dusty clay and hard state consistency clay was present. The land stratification resulted from test boring F_4 executed near the base of the landslide (Fig. 2) is approximately similar to the one obtained from test boring F_3 , except the fact that the thickness of the mass is lesser (about 2,50 m).

The dynamic penetrations P_2 and P_3 , executed near test boring F_3 and F_4 , have confirmed (based on the variation module in depth of the terrain resistance) the transition from the slid mass to the base layer, on which the landslide occurred.
