Landslides and tunneling geological failures, during the construction of Thessaloniki – Kavala Section of Egnatia Highway in N.Greece.

M. Chatziangelou & B. Christaras

Abstract—The present paper refers to the major part of the Egnatia Highway, about 100km long, which connects Thessaloniki and Kavala cities, at North Greece. Actually, it is divided in three parts: i) Nymphopetra-Asprovalta, about 40km long, ii) Asprovalta-Strymonas, about 20km long and iii) Strymonas-St. Andreas, about 40km long. The highway has already been constructed.

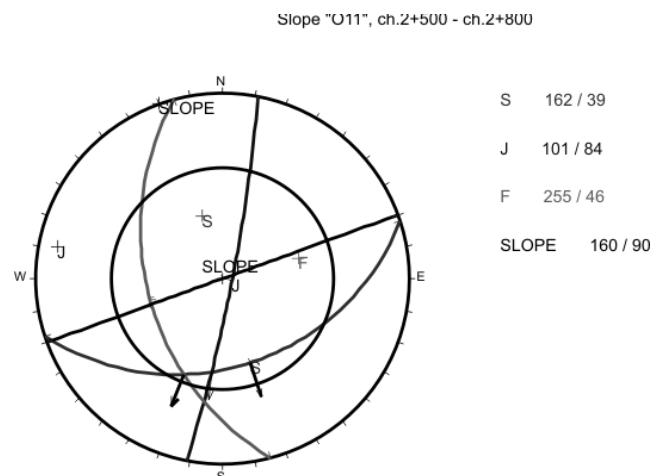
The slope "O11" consists of lake deposits. A fault of 255/46 cuts these deposits. The lake deposits may slide along the direction of the bedding 162/39. Two potential wedges were formed by; i) bedding 162/39 and fault 255/46 and ii) joints 101/84 and bedding 162/39. The sliding took place at SSW direction (Fig.2). Also, the critical slip cycle was estimated using slope geometry of 15m high and slope inclination of 90°. The radius of the critical circle was estimated 15m and the safety factor was calculated 3, for saturated conditions.

Fig. 2 Potential sliding along the slope "O11"

In order to protect the slope against sliding, a slope inclination of 34° was proposed. Using the proposed inclination, the radius of the critical circle was estimated at 29m and the safety factor was calculated 5 in saturated conditions.

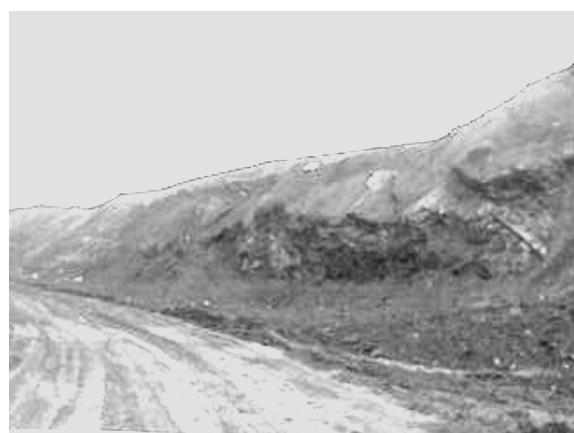
The slope is placed on the right hand of the road and consists of weathered gneiss with pegmatitic intercalations (Fig.3). The poor quality of the rock mass, together with the unfavorable orientation of the schistosity, affected the stability of the slope and caused extensive sliding. Two types of probable sliding were determined, according to our investigation. The first one referred to slope sliding along the schistosity with direction of 221/36, and the second one referred to potential wedge sliding. There was a potential unstable wedge, which was formed by the surfaces of a fault with direction of 195/60, the schistosity with direction of 221/36 and the joints with direction of 357/52.

Fig. 3 Slope placed on the right hand of the road

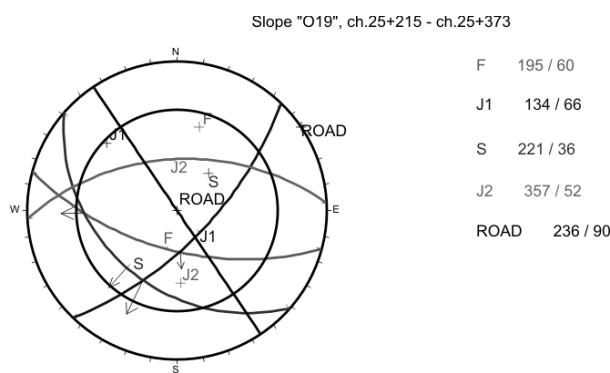
According to test Markland, 1972, the schistosity of the gneiss with direction of 221/36 was parallel to the strike of the slope causing planar sliding conditions. Two approaches were considered, in order to protect the slope from sliding (Fig.4).

Fig. 4 Potential sliding along the slope "O19"

- i. Change of the slope inclination, or
- ii. Change of the highway direction.

Considering that the second solution was almost impossible, the slope geometry was studied using the limited inclination in order to ensure the stability without changing the road design. Using an inclination more than 36° , ex. 45° (1:1), we could not protect the slope from sliding. This was because the plunge of the schistosity was located inside the area, which was bounded from the slope plane and a friction angle equal to 21° . So, if the average inclination would be less than 34° , the safety was ensured.

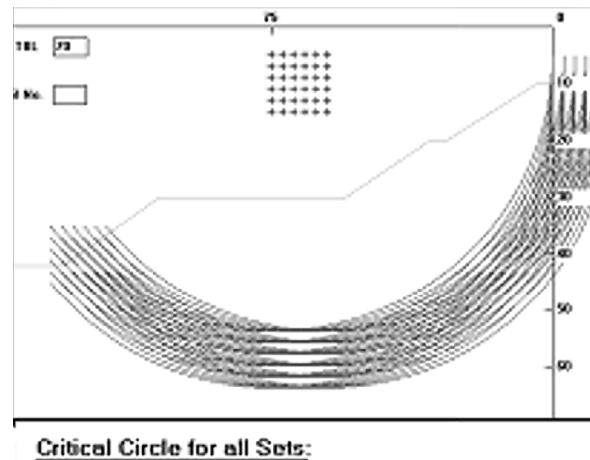
Two benches, 10m high were proposed, with inclination of 34° ($V : H = 2:3$). Low vertical benches, having width equal to 5m and height of 2,5m – 3,25m, designed to be created at the site of the embankment, so as the friction between the embankment and the slope to be increased. Using the geometry above, the slope in study was stable in dry conditions ($S.F. = 2$) and almost was unstable (or limited stable) in saturated conditions ($S.F.=1$) (Fig.5,6). After the construction of the embankment, the safety factor, in dry conditions, was estimated equal to 2 and in saturated conditions equal to 1 (instability).

Fig. 5 Circle sliding analysis and safety factor of slope "O19" after the embankment's construction , in unsaturated conditions

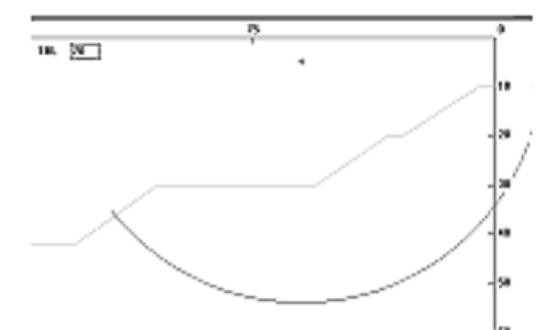
Fig. 6 Critical slip circle and safety factor of slope "O19" after the embankment's construction , in saturated conditions

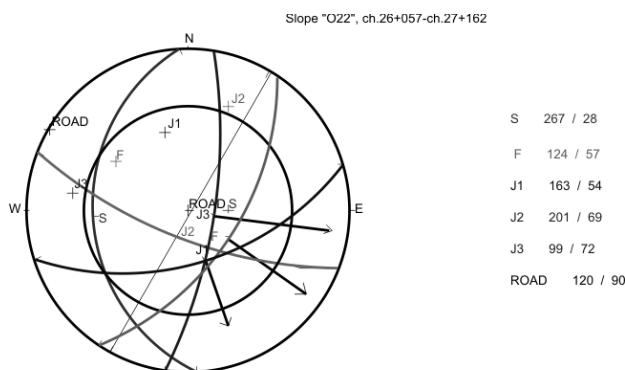
The slope “O22” consists of very cracked and totally weathered gneiss ($RQD = 5\%$), covered by sand formation of Pleistocene. The quality of gneiss of the slope was poor as the rock mass was very weathered and absolutely cracked ($RMR_{bas}=28$). For this reason, rock mass behaved as a soil. According to the SMR classification system, the slope was unstable. Studying the stability of the slope, the gneiss rock mass slipped along; i) the fault 124/57 and ii) the joints of 99/72. Potential wedges were also formed by joints 201/69, 99/72 and joints 124/57 parallel to fault. Sliding took place at SSE direction.

Fig. 7 Possible sliding along the slope “O22”

Terraces inclined at 45° were proposed to form the “O22” slope in order to be protected from planar sliding. The maximum height of the slope was about 50m. Taking into account that the slope consists of totally weathered gneiss ($\gamma=2,65 \text{ gr/cm}^3$, $\varphi=26^\circ$, $c=0$), there was a potential cycled sliding (Fig.7). But according to slope stability analysis in saturated conditions, the slope was stable as the calculated safety factor of the critic circle was 7.

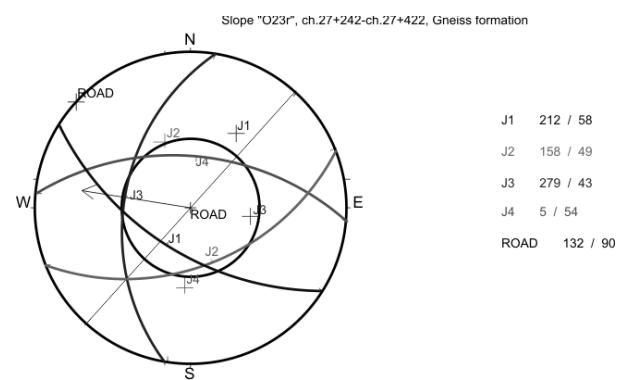
Fig. 8 Possible sliding on gneiss at slope “O23r”

the “O23r” slope, the type of probable sliding was; i) a planar sliding of gneiss rock mass along the joints directed to 279/43 and ii) a potential wedge sliding at west direction. The planes of joints 212/58 and 279/43 formed the wedge (Fig.8). The marble rock mass sliced along the joints of 287/71 (Fig.9). As the rock mass was slightly weathered, there was no possibility

In order to protect the slope, against sliding, an inclination of slope equal to 45° was proposed.

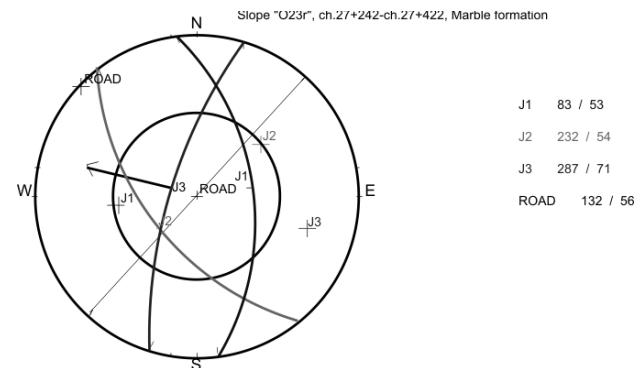
Fig. 9 Possible sliding on marble at slope “O23r”

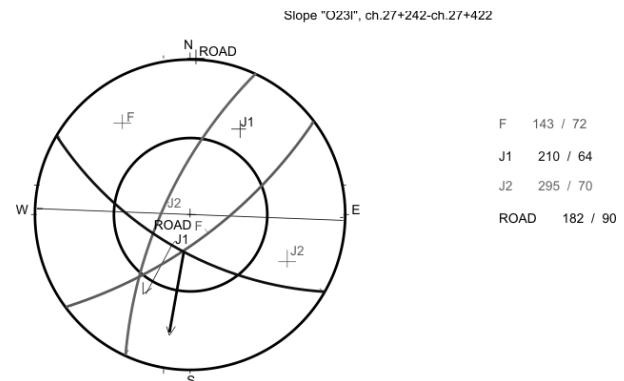
of cyclic sliding. The gneiss rock mass of the “O23l” slope sliced along the planes of joints 210/64. A potential wedge, being formed by the joints of 210/64 and joints parallel to fault 143/72, sliced at South direction (Fig.10). As the rock mass

Fig. 10 Possible sliding along the slope “O23l”

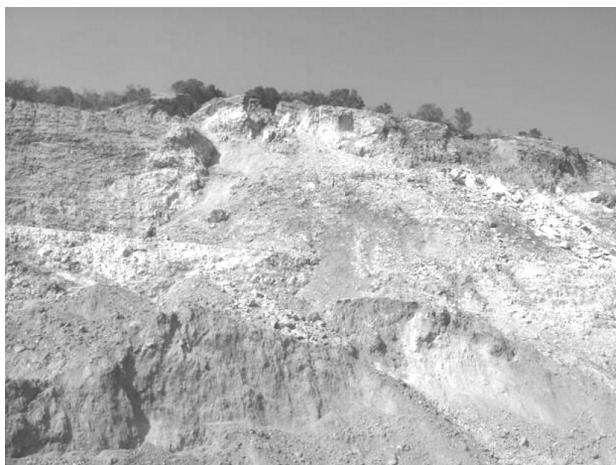
The slope, 60m high, consists of medium to high weathered, cracked biotitic gneiss. The water of a short rainfall decreased the safety of slope and created landslide. The landslide was bounded at the half-formed part of the slope (Fig.11). Rock mass quality was poor (category IV). Tension crack caused circular soil sliding. The critical circle in unsaturated conditions, was 50m deep and the safety factor was calculated 1,66. In saturated conditions, caused by rainfall, the safety factor was 1,16. A short rainfall, which had taken place on March 2002, created a landslide of the half part of the slope, which was just excavated using a beginning geometry. The slope consisted of small rock blocks. A cyclical sliding of loose material was bounded at east side of slope, where was a fault surface (115/65) and at west side of slope, where was a long sliding surface (120/76) (Fig12). Rainfall was the main cause of landslide at the safety factor (1,16) in saturated conditions was ultimate (Chatziangelou & Christaras, 2005).

Fig. 11 Landslide at ch.9+700 along the road

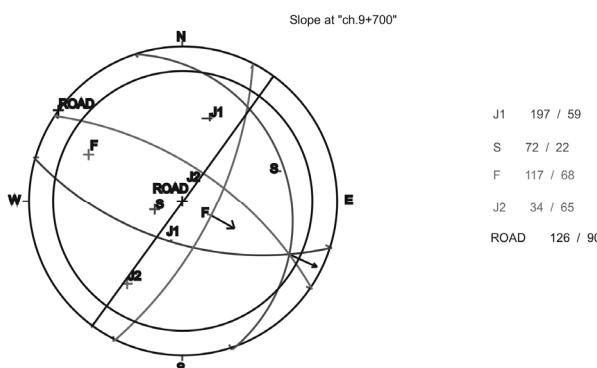
Fig. 12 Possible sliding along the slope at "ch.9+700"

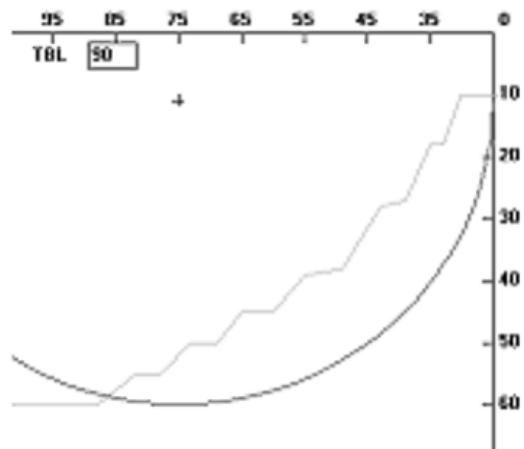
X Cen	Y Cen	Radius	Slices	Safety Fac
50.00	11.00	50.00	62	2.08

Fig. 13 Critical slip circle and safety factor of slope at "ch.9+700" using the proposed geometry in unsaturated conditions

For landslide restoration and support, dips of downstairs were proposed to be smaller (height/width=1/1.5 and 1/1) than dips of upstairs (height / width = 2 / 1). Using this new geometry, the safety factor was 25% higher (SF = 2.08) at unsaturated conditions and 35% higher (SF = 1,57) at

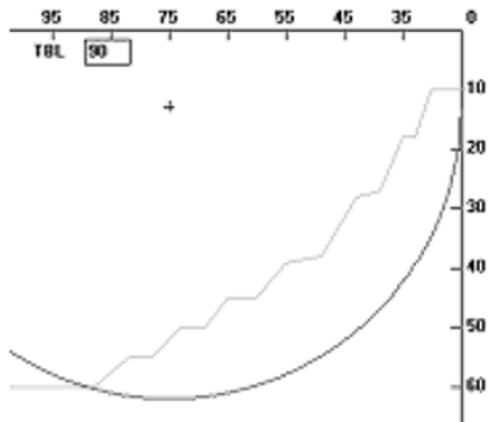
X Cen	Y Cen	Radius	Slices	Safety Fac
50.00	13.00	50.00	67	1.57

Fig. 14 Critical slip circle and safety factor of slope at "ch.9+700" using the beggining geometry in saturated conditions

saturated conditions than using the beginning geometry. The benches of the slope were designed about the same length so as the length did not affect the safety factor and pore pressure. Thus, safety factor depended only on inclination of benches. According to the new geometry, big dips were formed downstairs and small ones were formed upstairs. When the height was also increased, restrained powers were increased and sliding powers were decreased. So, the safety factor of every part was progressively increased downstairs to upstairs making slope stable (Fig.13,14).

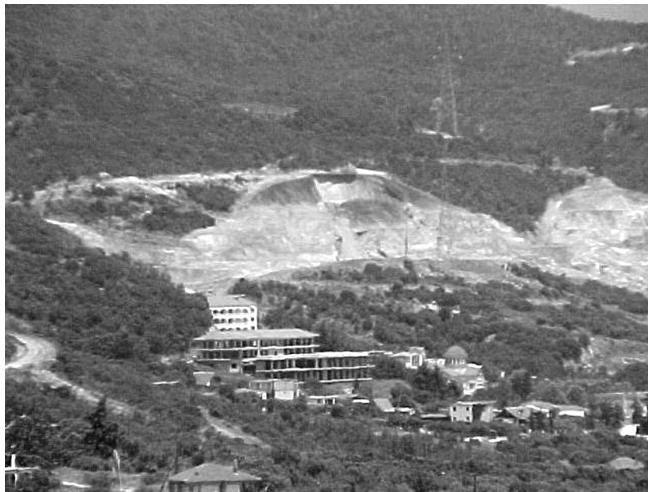
An open trench was planed to be constructed at the southern part of the Asprovalta tunnel II in order to replace the right bore of the tunnel (Fig.15). The excavation was performed from the upper parts to down slope. The geological formations, which were analyzed during the excavation were folded gneiss with joints of north and southeast directions, folded marble with joints of west and southeast directions, folded amphibolite, whose schistosity was oriented to northeast and southeast and the joints were of south and west directions. The gneiss and marble were co-folded and cut by three faults with NW, NE and SE directions.

Fig. 15 The landslide in study

According to RMR classification system, the rockmass quality was characterized as poor ($RMR_{bas} = 22-40$, $RMR = 3-17$). There was a part of slope between ch.10+570 and ch.10+640 consisting of amphibolite and marble formations with better rock mass quality ($RMR_{bas} = 42-49$, $RMR=24-35$) than the rest part of the slope. According to SMR classification system, the excavation of the slope was very unstable and extensive failures were expected.

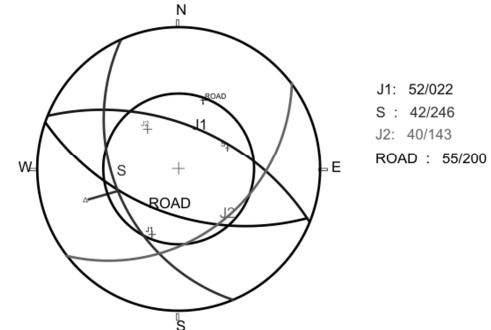
Asprovalta tunnel II, Right bore, 2nd bench, CH.10+510-CH.10+520, GNEISS

Fig. 16 Potential sliding in gneiss along the 2nd bench, between ch.10+510 and ch.10+520

bench, might slide along the direction of schistosity 213/35. The same formation, being placed between ch.10+510 and ch.10+520 of the 2nd bench, might slide along the direction of schistosity 246/42 (Fig.16). There was a part of completely weathered gneiss, being placed between ch.10+670 and ch.10+680 of the 2nd bench, which might slide along the direction of the section being formed by schistosity 229/48 and joints 169/53 or 125/85. Marble formation, being placed between ch.10+600 and ch.10+640 of the 2nd bench, might slide along the direction of the section being formed by schistosity 195/39 and joints 278/76 (Fig.17, 18).

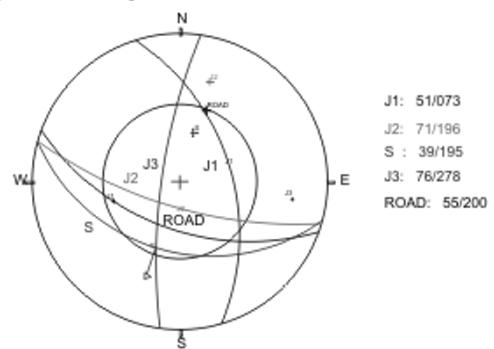
Asprovalta tunnel II, Right bore, 2nd bench, CH.10+600-CH.10+640, MARBLE

Fig. 17 Potential sliding in marble, along the 2nd bench, between ch.10+600 and ch.10+640

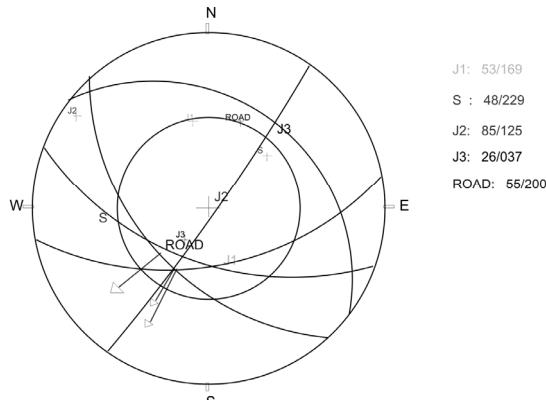
Asprovalta tunnel II, Right bore, 2nd bench, CH.10+670-10+680, COMPLETELY WEATHERED GNEISS

Fig. 18 Potential sliding in complete weathered gneiss, along the 2th bench, between ch.10+670 and ch.10+680
