# Technical Aspects on a Landslide Affected Construction

Andreea-Terezia Mircea

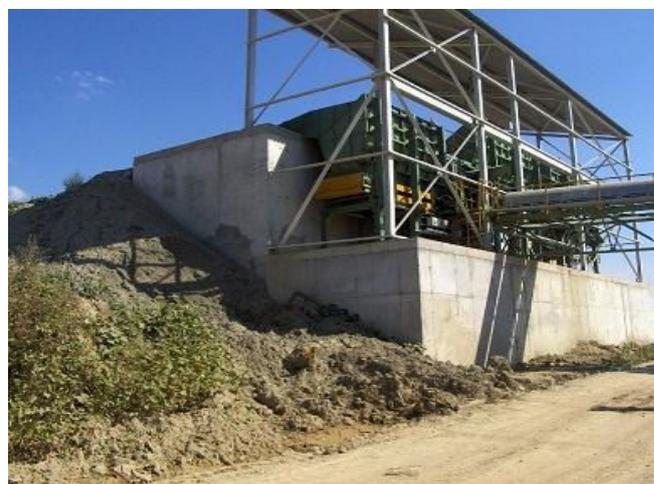
Fig. 1 Structure of the box feeder

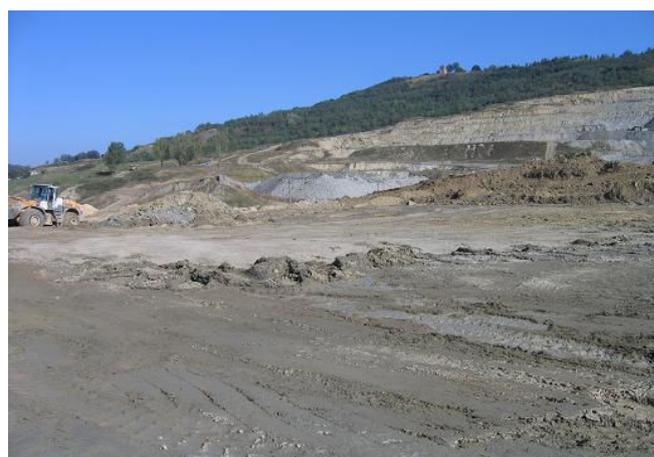
Fig. 2 The storing platform behind the feeder

Behind this new construction, a platform for storing the necessary raw material for bricks fabrication was arranged (Photo from Fig. 2).

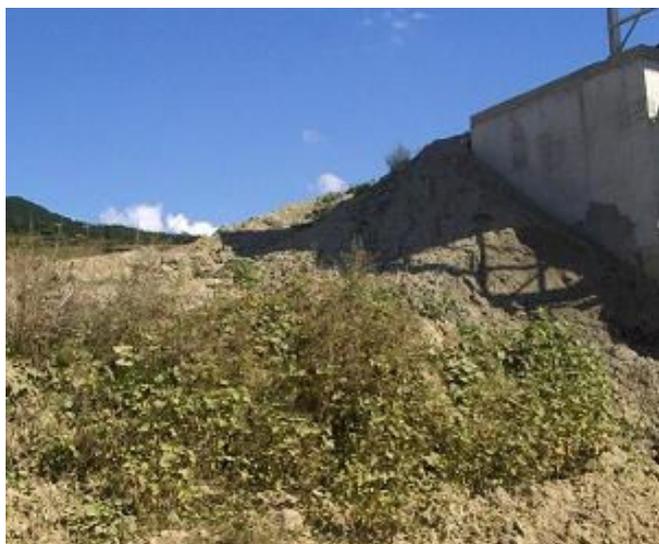
Only few months after the feeder was put into operation the surrounding land filling structure showed signs of deformations, swelling and fractures, as an obvious evolutionary process (Photo from Fig. 3).

Fig. 3 Deformations, swelling and fractures of the surrounding land filling structure

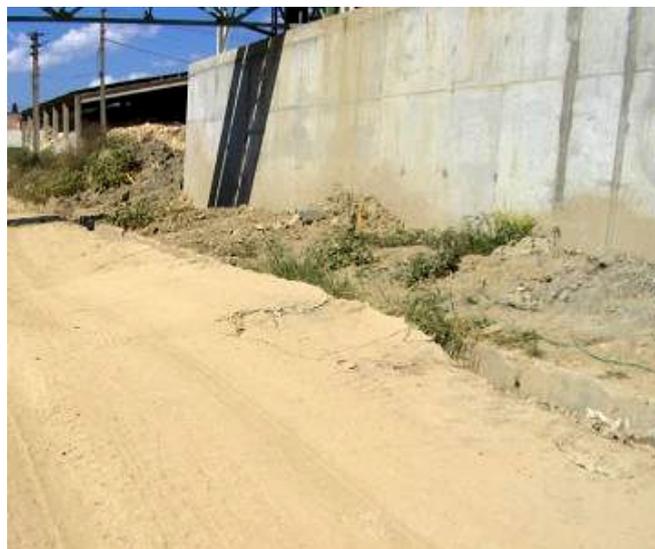
Consequently the terrain deformation and movement produced translations and rotations of the structure (Photos from Fig. 4 and 5).

Fig. 4 The soil deformations produced translations and rotations of the structure

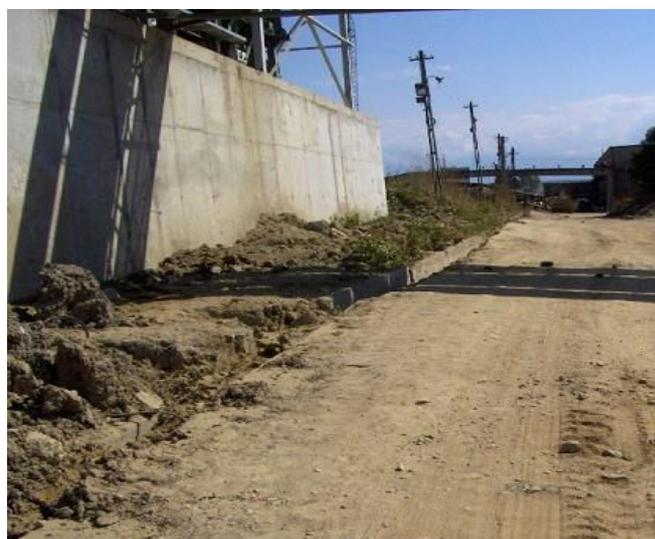
Fig. 5 Soil deformations in front of the structure

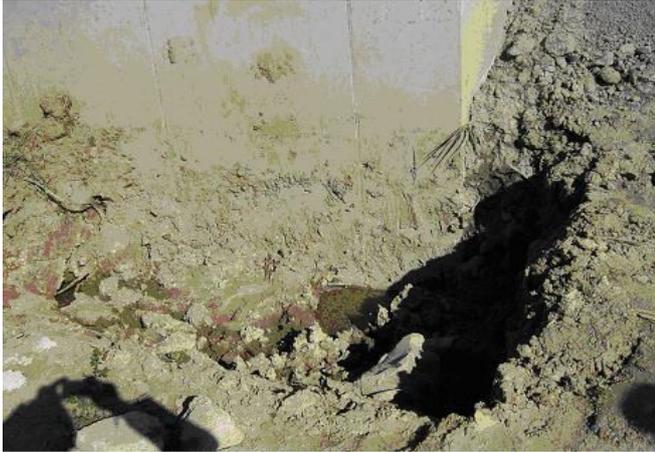
- The foundation type of the investigated construction object is of reinforced concrete having a width of 1.50 m;
- The foundation depth is about 2.10 m from the surface of the ground in the surveyed area;
- The ground stratification intercepted as a result of drilling is shown on the stratigraphic column from Fig. 11;
- At the depth of 3.0 m from the ground surface a layer of soft plastic clay, which has low strength characteristics and deformation properties was found, so that the loads generated by the earth filling and the raw materials stored in the adjacent platform provoked deformations on the surrounding land filling structure.

Fig. 8 The survey performed at the foundation of the investigated construction object

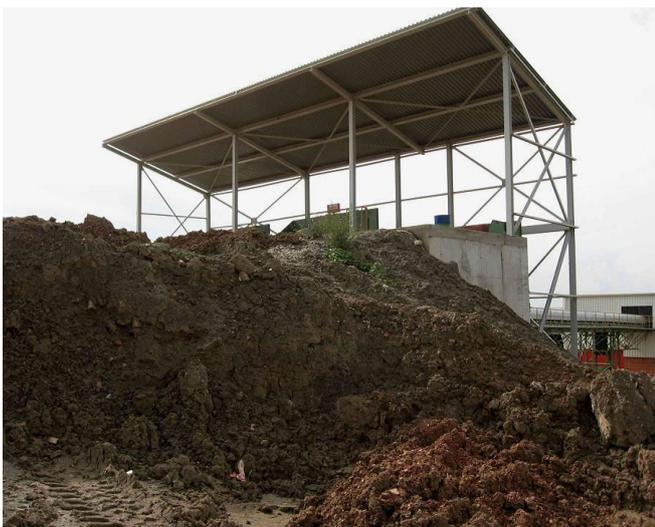
Fig. 9 Construction of the storing platform behind the box feeder

- A landslide phenomenon started in the earth filling area, caused by the storing platform arranged behind the box feeder's structure (see Photos from Fig. 9 and 10).

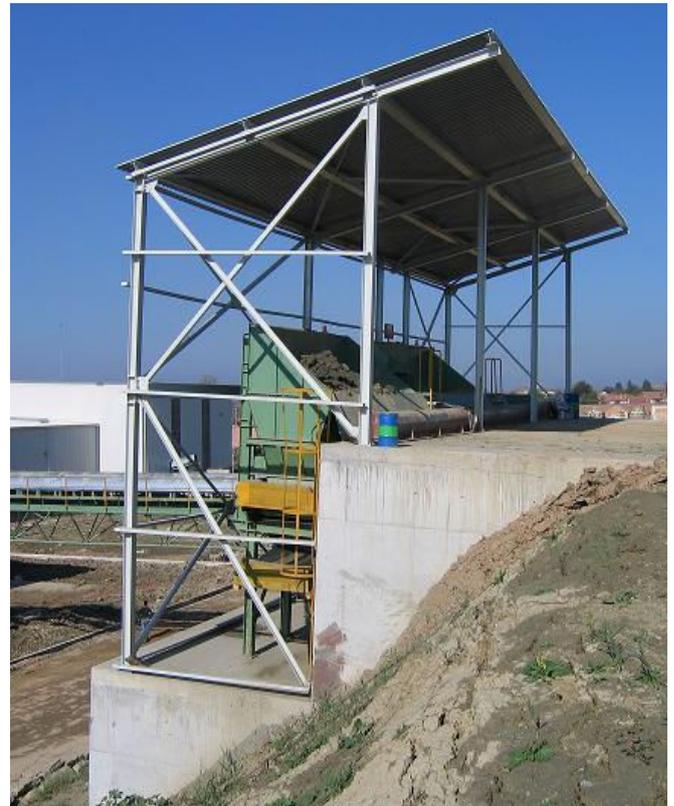
Fig. 10 Side view of the box feeder's structure

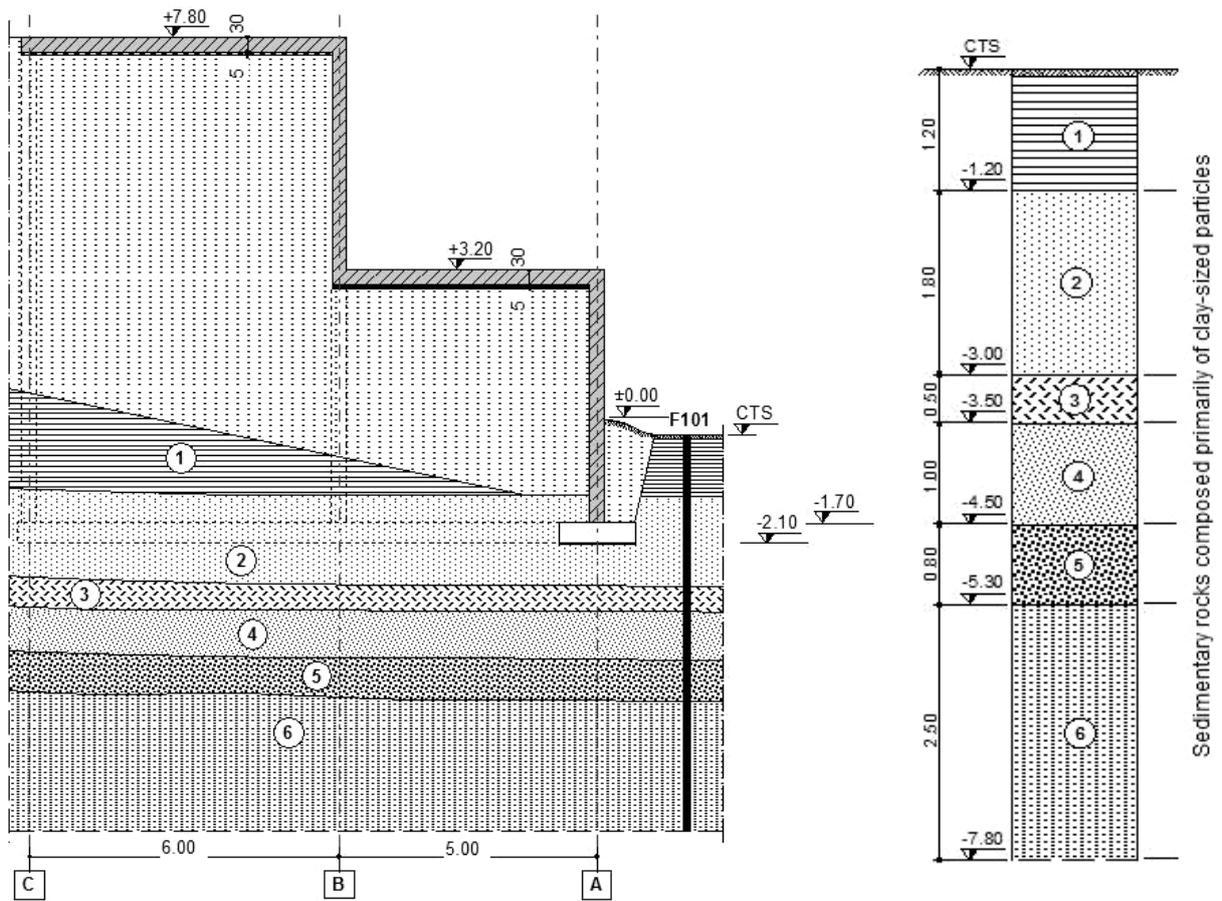
- Below the structure's foundation level a gray-yellow layer of soft plastic clay has been detected, having a thickness of about 50 cm, with reduced strength and rigidity properties (layer no 3 of the stratigraphic column shown on Fig. 11).

Fig. 11 Ground stratification and the stratigraphic column

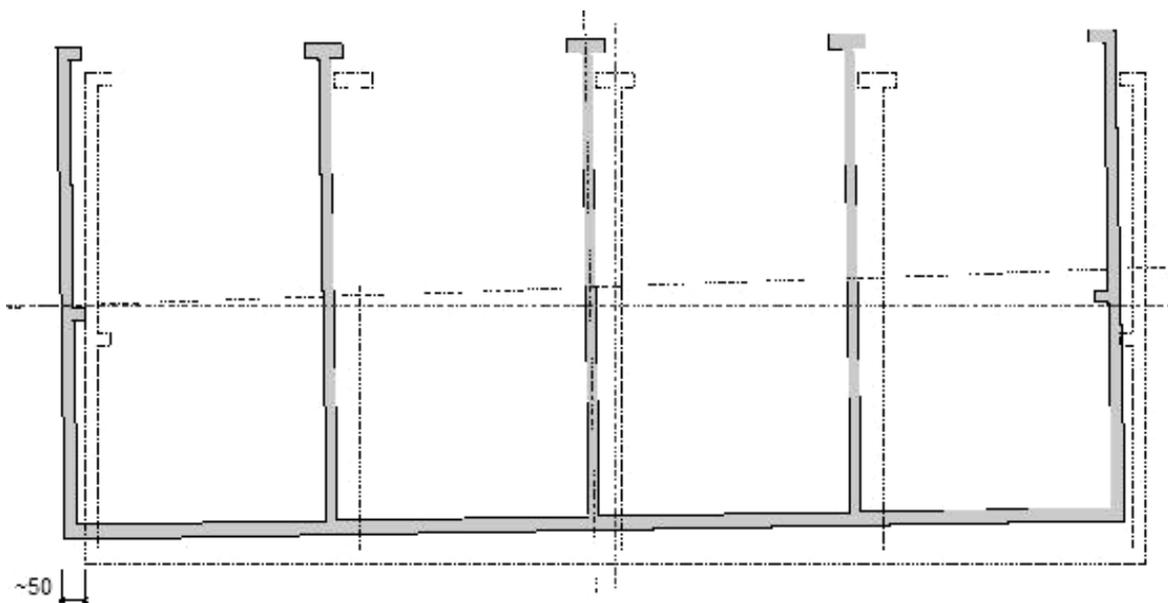
- The structural system of the feeder is very a rigid box, so that the registered landslide into a plan of soil created in the layer no 3 (gray-yellow soft plastic clay) produced a rigid body rotation and translation of the structure (Fig.12);

Fig. 12 Rotation and translation of the structure

a) Stopping the landslide in transverse direction by blocking it with a tangent pile screen stiffened by a superior foundation, positioned next to the construction's object longitudinal axis A, in order to prevent slide movements in the longitudinal direction, as well as providing reinforced concrete beams supported each on two piles under the foundation base of the transverse axis C;

b) Stopping the landslide in transverse direction by blocking it with a tangent pile screen stiffened by a superior foundation, identical to the previous solution, and in addition by blocking the slide in longitudinal direction using a tangent pile screen adjacent to the transverse axis 1, similar as for the transverse direction.

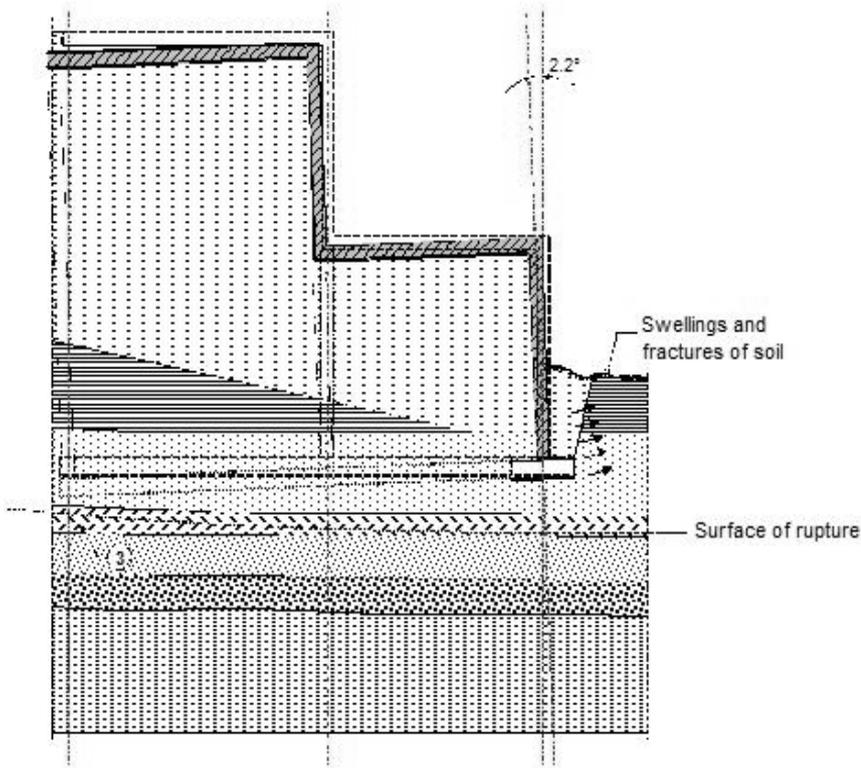
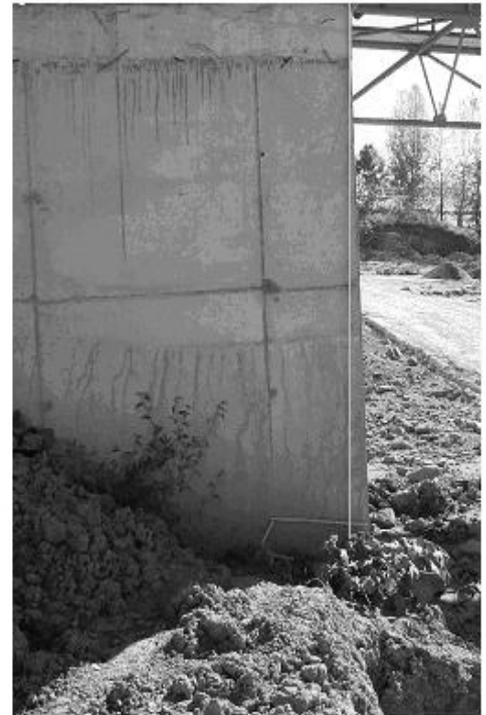
- The rotation took place with predilection on transverse direction, and the translation mainly on the longitudinal direction (Fig. 13 and 14), some of the deformations reaching about 50 cm from the initial position, as well as visible fractures of the superficial layer.

Fig. 13 Transversal rotation of axis 1, and soil deformation

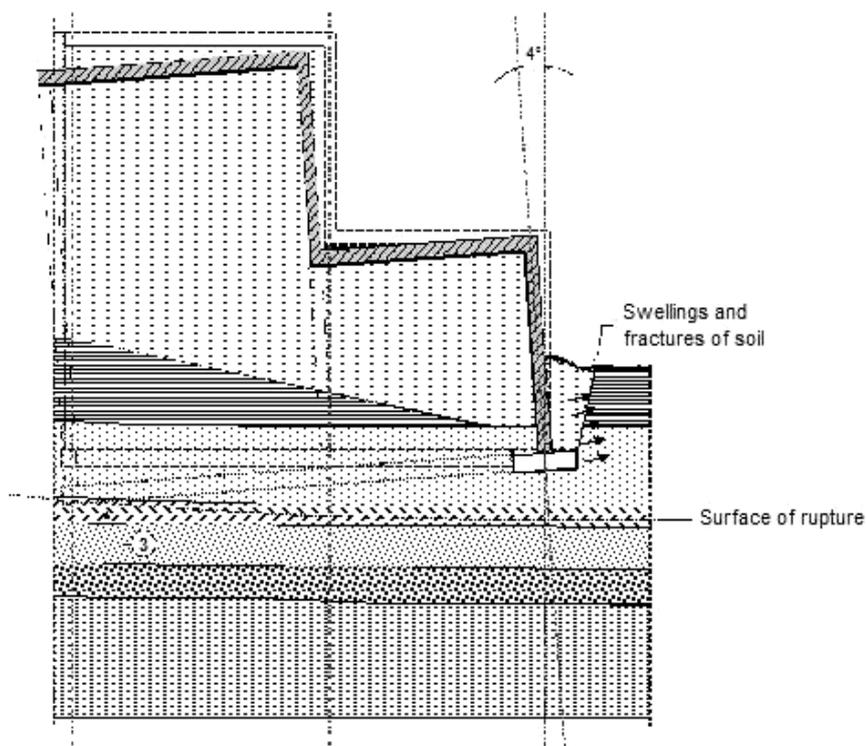
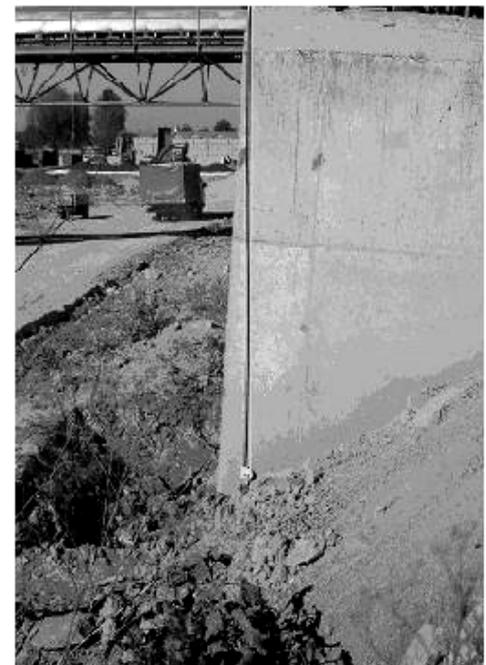
Fig. 14 Transversal rotation of axis 5, and soil deformation

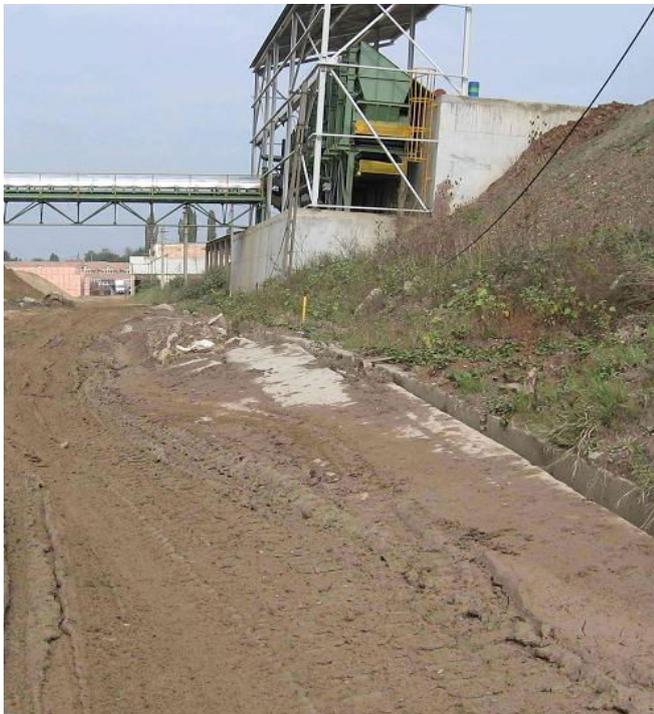
- The characteristic of soft plastic clay, of being susceptible to earth flow, as well as the rotation of the structural system that took place, explain the fact that the access road is swelled in front of the box feeder on a length of about 15 m (see Photo from Fig. 15).

Fig. 15 The access road is deteriorated on a length of about 15 m

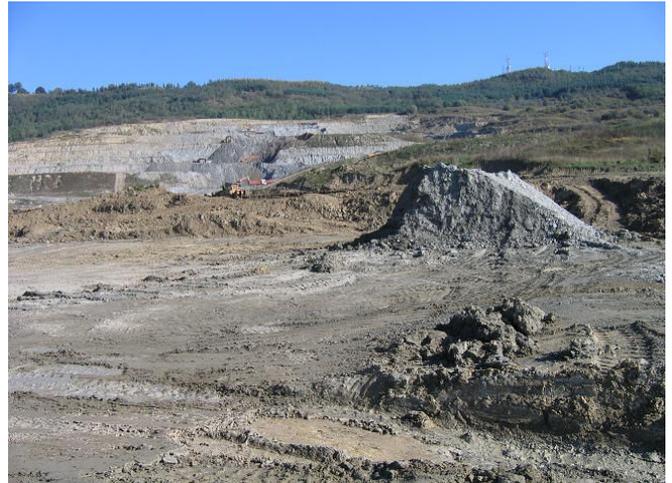
At the time of performing the investigation the phenomenon was not yet stabilized and furthermore it could be amplified by the soil-infiltrated water from the proximity slopes (see Photo from Fig. 16), and its leakage through the earth fill structure.

Fig. 16 Amplification of the deformation process due to the possibility of water infiltrations from the proximity slopes
