Experimental analysis of areas susceptible to fracture in hot-pressed ceramic crowns

L. Porojan, S. Porojan, M. Bîrdeanu, C. Savencu, A. Cernescu and F. Topală

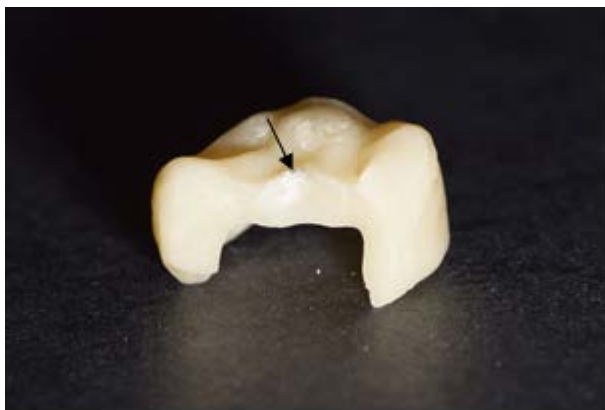
Fig. 4. Fracture surface of a pressed ceramic crown specimen exposing fracture origin on the occlusal loading point and the fractographic map.

The exact origin of the crack is located at the loading area (generated during experimental tests) and from there a critical crack started and propagated along the axial and occlusal walls until fracturing the whole crown into two parts, used for the fractographic analysis (Fig. 4, 7).

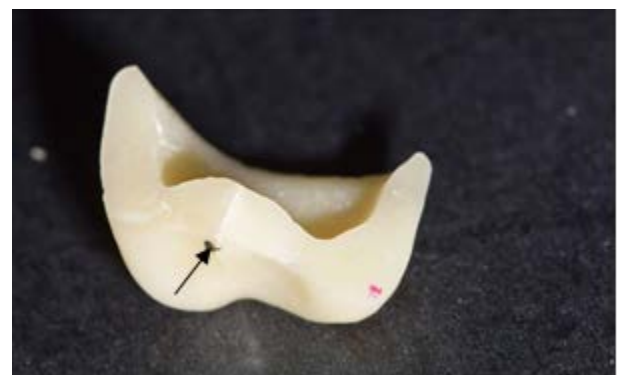
Fig. 7. Fracture surface of a pressed ceramic crown specimen exposing fracture origin on the occlusal loading point and the fractographic map.
