The geo-radar in the service of concrete durability

K.HADJA and F.KHARCHI

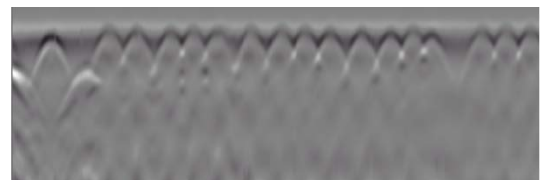
We analyzed using GPR profile a construction which has two different areas, the first one corresponded to relatively sound concrete Fig .16-a, and the second area corresponded to degraded concrete. Fig .16-b.

Fig.16-a The relatively sound concrete area with its radar profile

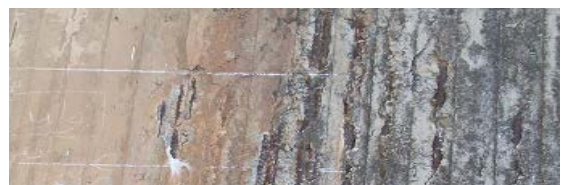
Fig.16-b The damaged concrete area (the right side) with its radar profile (present bars strongly corroded)

The horizontal radar profiles show the presence of a severe corrosion specially in the right side of the construction which is strongly damaged characterized by its low reinforcement cover and some bars are without coating .

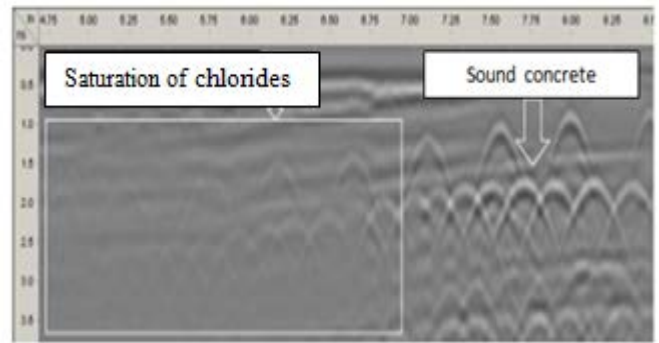
The profiles can also indicate the presence of chlorides, the fig 18 shows that in areas where there is a sound concrete (protected by asphalt) , the signal presents a visible hyperboles , the left area (unprotected) present a uniform and high attenuation due to the saturation of chlorides in this zone.

Fig. 18 Attenuation of signal due to the presence of chloride in the concrete
