Durability of GCB concrete exposed to sea water sulphates in the region of Jijel – Algeria

Abstract—Significant deterioration has been observed on marine structures in the Jijel region, due to the low quality of the concrete produced and the aggressive nature of the external environment. The aim of this work is to study on concrete durability the grooved cubic blocks (GCB) immersed in the seawater near the North West pier of the port of DjenDjen under the effect of sulphates. On will retrieving cores from GCB immersed in sea water for 25 years at DjenDjen and the results obtained will compare with control specimens. Based on this study, it was concluded that the GCB concrete exhibited weak mechanical characteristics compared to the control specimens concrete, and a relatively slow penetration of the aggressive agents; as well as a significant reduction in compressive strength by 45 % of cores; and by 7 % for speed of sound at the age of 25 years. At the same age the carbonation depth test reached to 117.00 mm.

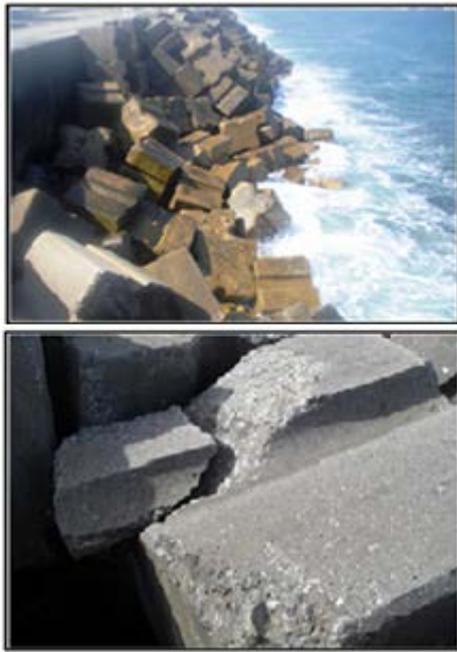
Fig. 1 shelling GCB at the coronation of the pier North West of the port DjenDjen.

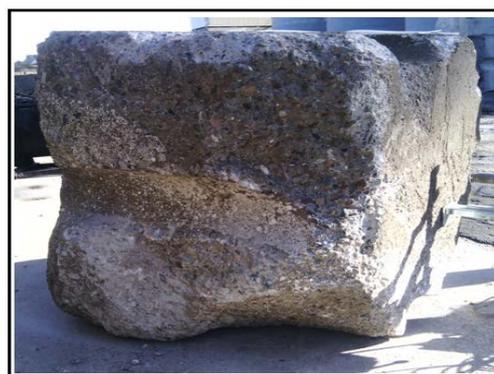
In this study, a grooved cubic concrete block (GCB) having a volume of 4 m^3 was chosen. This block had been continually immersed in seawater for a period of 25 years to protect the North West jetty of the port of Djen Djen, and the removal of the GCB executed by a crane. These GCB manufactured in the early 1989 (Fig. 2); by Using of SRC (Sulphate Resistant Cement) concrete (CEM I 42.5 N-ES) from the LAFARGE factory; physical and chemical properties of the used cement illustrated in Tables II. With an adjuvant superplasticizer between 0.7 - 0.9 % of and fine aggregate (the nominal largest size of fine aggregate or sand used was 5 mm), and coarse aggregate (the nominal maximum size of coarse aggregate used was 25 mm). Table III summarizes the concrete GCB mixture compositions.

Fig. 2 GCB of 4 m^3 retrieved from seawater.

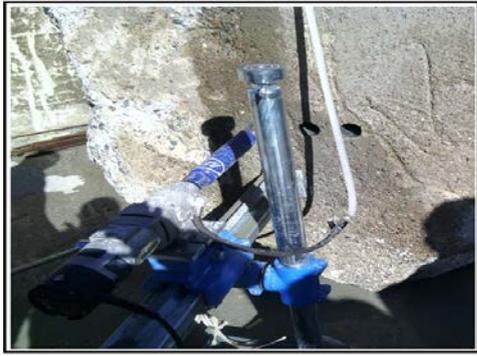
Typically, the GCB concrete gives a class C25 indicating an average compressive strength of 25 MPa. The coring performed on the non-contact part to the swell (See Fig. 3) according to European standard NF EN 12504-1, and finally these carrots cut in the form of cylinders 50 mm in diameter and 100 mm in length (See Fig. 4). Thereupon the surfaces of these cylindrical specimens are pre-treated for mechanical, physical and chemical tests.

Fig. 3 GCB coring in concrete.

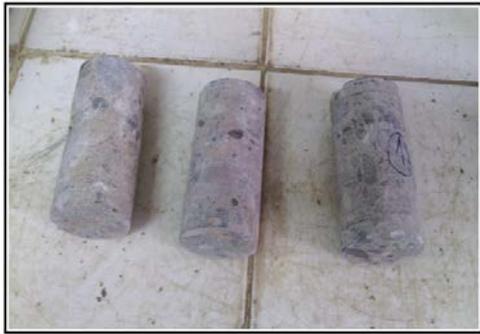
Fig. 4 concrete cylinders (carrots).

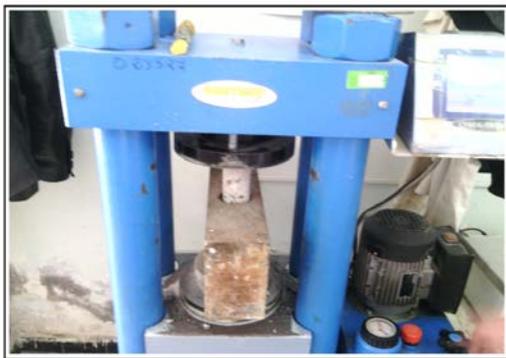
Fig. 5 compressive strength test of carrot.

The aim of the experimental work is to study the degradation mechanism physic-chemical in concrete specimens immersed in the real aggressive environment (Seawater) for a 25 years (See Fig. 5). Compression test carried out in the lab by using concrete cylindrical specimens of dimensions ($D = 50 \text{ mm}$, $H = 100 \text{ mm}$) according to European standard NF EN 12390-3. The results of the compressive strength for carrots and for references specimens illustrated in Fig. 6.
