Modal parameters identification on environmental tests of an ancient tower and validation of its FE model

M. Diaferio, D. Foti, and N. I. Giannoccaro

Keywords— Non-destructive tests, operational modal analysis, non-linear FE model, dynamic analysis, model updating.

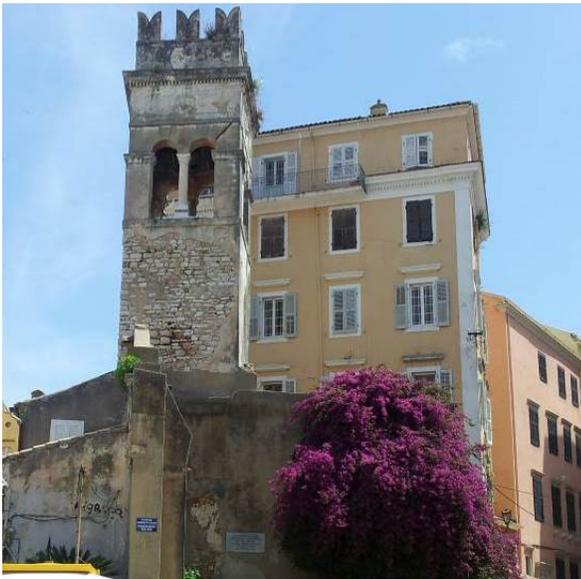
Fig. 1. Annunziata bell tower.

In this paper the bell tower of Annunziata Church has been investigated. It is a masonry tower, which shows a high damaged scenario (Fig. 1). It is located in the center of the town of Corfù in Greece. The Annunziata Church was built in 1394 and was part of a Roman monastery. Inside the church [1] there were the tombs of the generals who died in the sea battle of Naupactus (1571). The Church of Annunziata was bombed during the Second World War and it suffered from cracking; then it collapsed in March 1952 when long term phenomena and earthquakes contributed to increase the damage. So, from 1952 only the campanile of the medieval monastery has survived to the present day with heavy cracking. The bell tower is a stone tower with an almost square plan section. A double arched-window supported by a stone column in the center is located at each of the four façades (Fig. 1). It should be emphasized the problems connected to the modeling of this part of the tower due to difficulties of instrumenting it as better explained in the following sections. In addition, the slenderness of the columns of the arched-windows cannot be modelled as linear elements and this peculiarity must be taken into account in the analysis of the results when compared to the preliminary model.

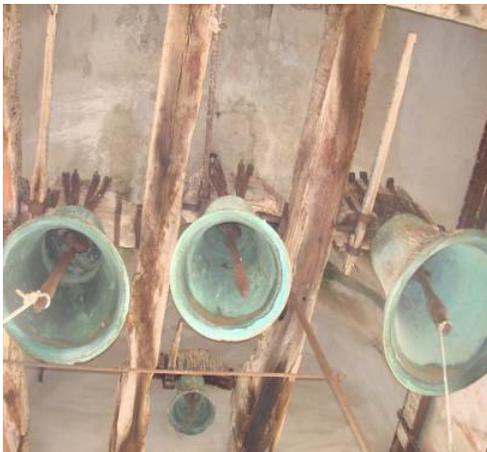
Fig. 2. The four bells of the tower.

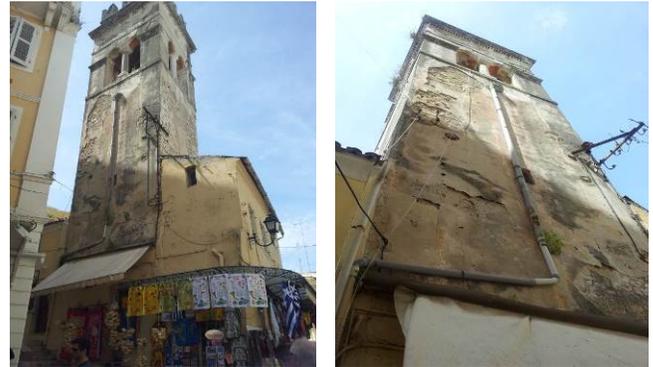
Fig.3. The damaged state of Annunziata bell tower.

The structure of the tower consists of masonry walls; three floors made by solid bricks are supported by vaults. At the top of the tower there is the bell cell with four bells (Fig.2). The actual state of the tower may be defined critical, with many damages and cracking. It is possible to observe deep vertical and diagonal cracking, deterioration of mortar on the stonewalls and development of creepers in the masonry (Fig.3).

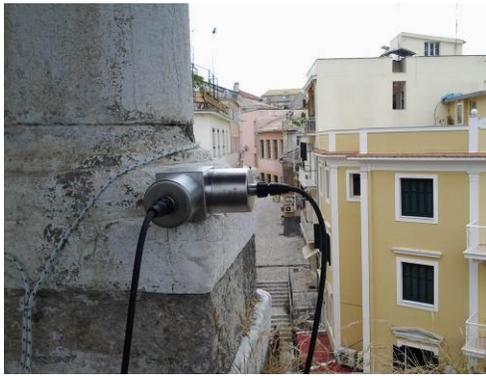
Appropriate rectangular blocks were designed and realized in order to ensure the orthogonality of the couple of accelerometers placed on the same position. The accelerometers were inserted with screws on the threads realized on the perpendicular faces of the block (Fig.5).

Fig.5. Two monoaxial accelerometers positioned at the base of a column of an arched-window of Annunziata bell tower.
