# Optical Coherence Tomography and Micro Computer Tomography Investigations on Pressed Ceramic Veneers

**Keywords**— Ceramic Veneers, Optical Coherence Tomography, Micro Computer Tomography

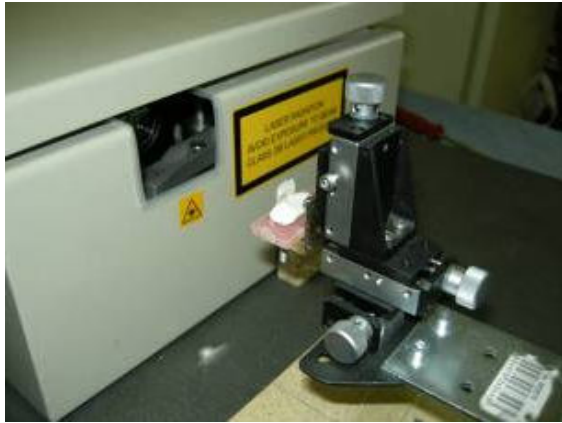
Fig. 2. Aspects from the scanning procedure of the ceramic veneers.

54 Empress Veneers (Ivoclar Vivadent, Lichtenstein) were investigated using en face Optical Coherence Tomography (OCT) (Fig.1). The scanning procedure was performed vestibular, oral, mesial and distal for each sample (Fig.2).

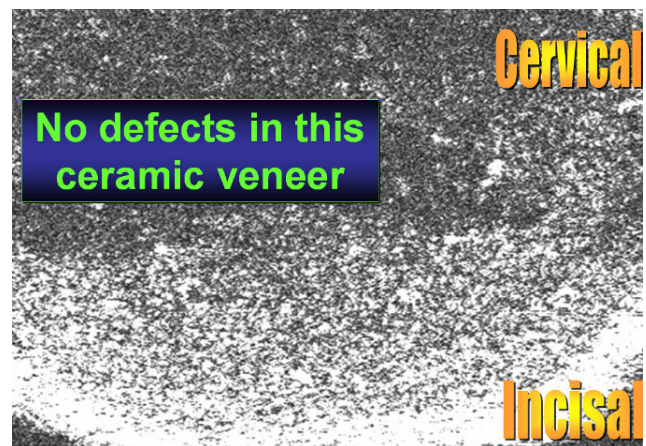
Fig. 13. En Face OCT investigation of ceramic veneer sample nr.7. Slice 27 from 110 stuck images with 18 degree scanning.

Fig. 14. En Face OCT investigation of ceramic veneer sample nr.7. Slice 36 from 110 stuck images with 18 degree scanning.

The ceramic veneer sample nr.7 revealed no defects inside the structure. The en face scanning was made in incisal, medium and cervical areas in order to have a good evaluation of the sample (Fig. 13 – 14). For a better visualization a three dimensional reconstruction was developed (Fig. 15). The evaluation performed by micro computer tomography validated the results obtained by the optical coherence tomography investigations performed in en face mode. In case of sample nr. 7. the ceramic structure was compact. This kind of investigations performed before inserting and bonding the ceramic veneers in the oral cavity could prevent fractures caused by the stress concentrators from inside the structure that become active in a biomechanical environment.
