Controversies and comments regarding some fortifications and construction techniques with burnt materials from southwestern Romania

VLAD VINTILĂ ZIRRA
 Institute of Archaeology
 11 Henri Coandă Str., Bucharest, ROMANIA
 vvzirra@yahoo.com

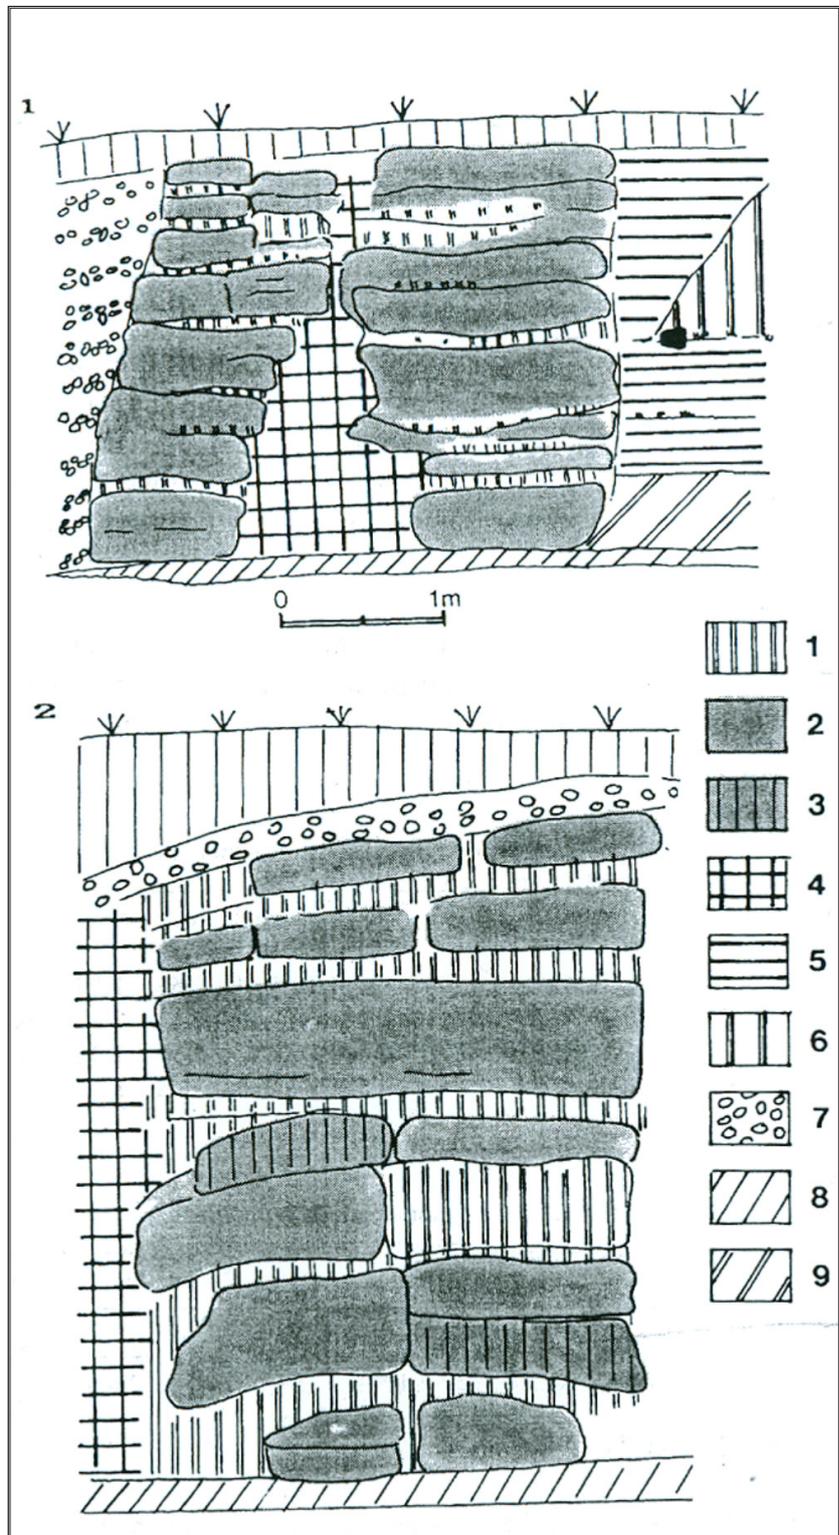
Figure 2: Coțofenii din Dos. Profile sketch of the raw adobe brick paraments in the "mound" area (after M. Babeş, *Despre fortificațiile „Cetății Jidovilor“ de la Coțofenii din Dos*, SCIVA 48, 1997, 3, 208-211, fig. 4)..

mentioning the section or cassettes **Fig. 2**) which he drew when visiting “Cetatea Jidovilor” in 1986 [23]. In fact, the excavation authors’ remarks are the same but without “seeing” so clearly this kind of structure [24]. Even if we admit that M. Babeş issued a solid hypothesis we can’t extend it to the entire fortification (approximately 250 m long). In fact it is more about the exception that makes the rule, especially when probably it is about an ulterior intervention after the bricks and burnt emplecton wall were erected.

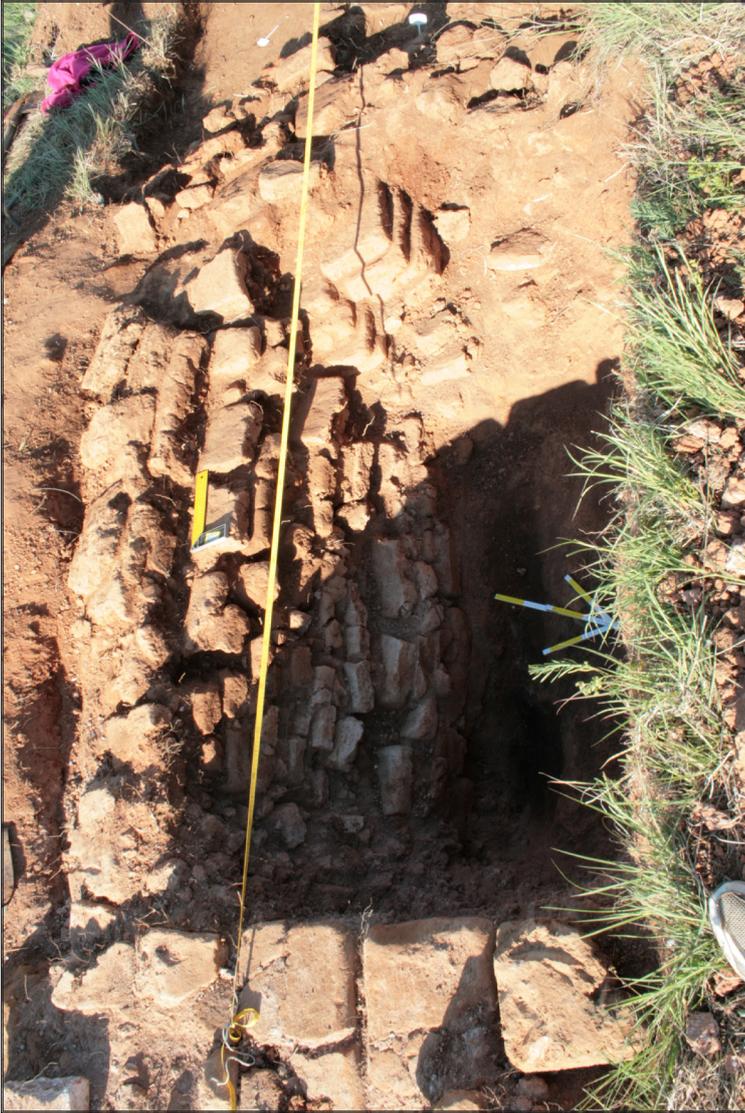
Figure 3: Coțofenii din Dos, unpublished survey 2009, excavations V.V. Zirra, Olimpia Bratu and Al. Bratu; interior (down) and exterior (above) burnt brick paraments and *diatonos* (left) between them.

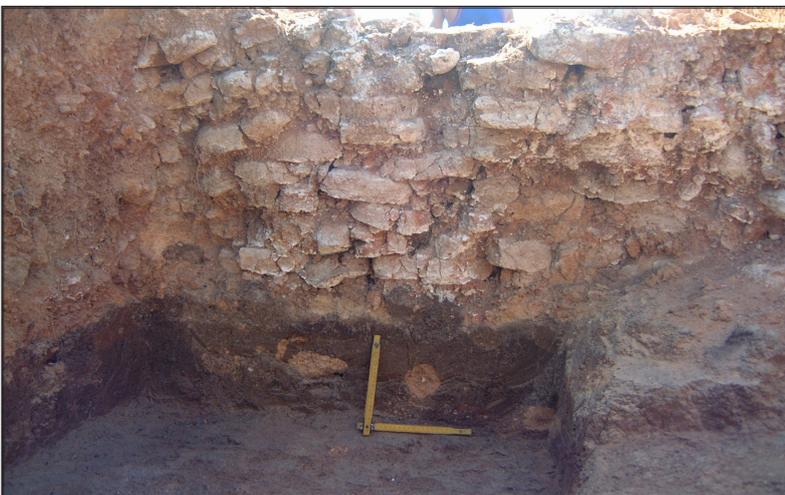
Figure 4: View of the interior burnt brick parament, (trench X/2002)

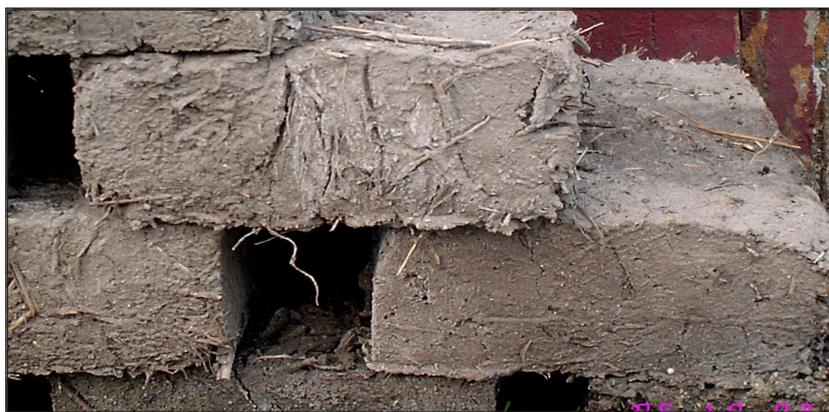
Figure 5: Contemporary adobe bricks exposed for drying in open air in the yard of a local.

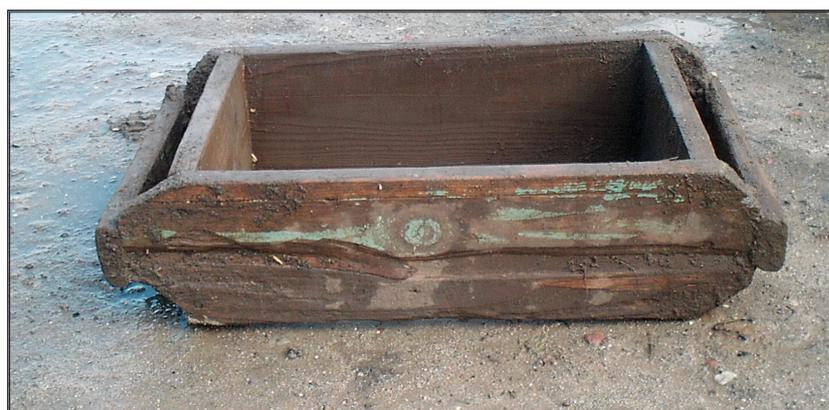
Figure 6: Contemporary wooden mold for formatting adobe bricks. Utensil used by the same local.

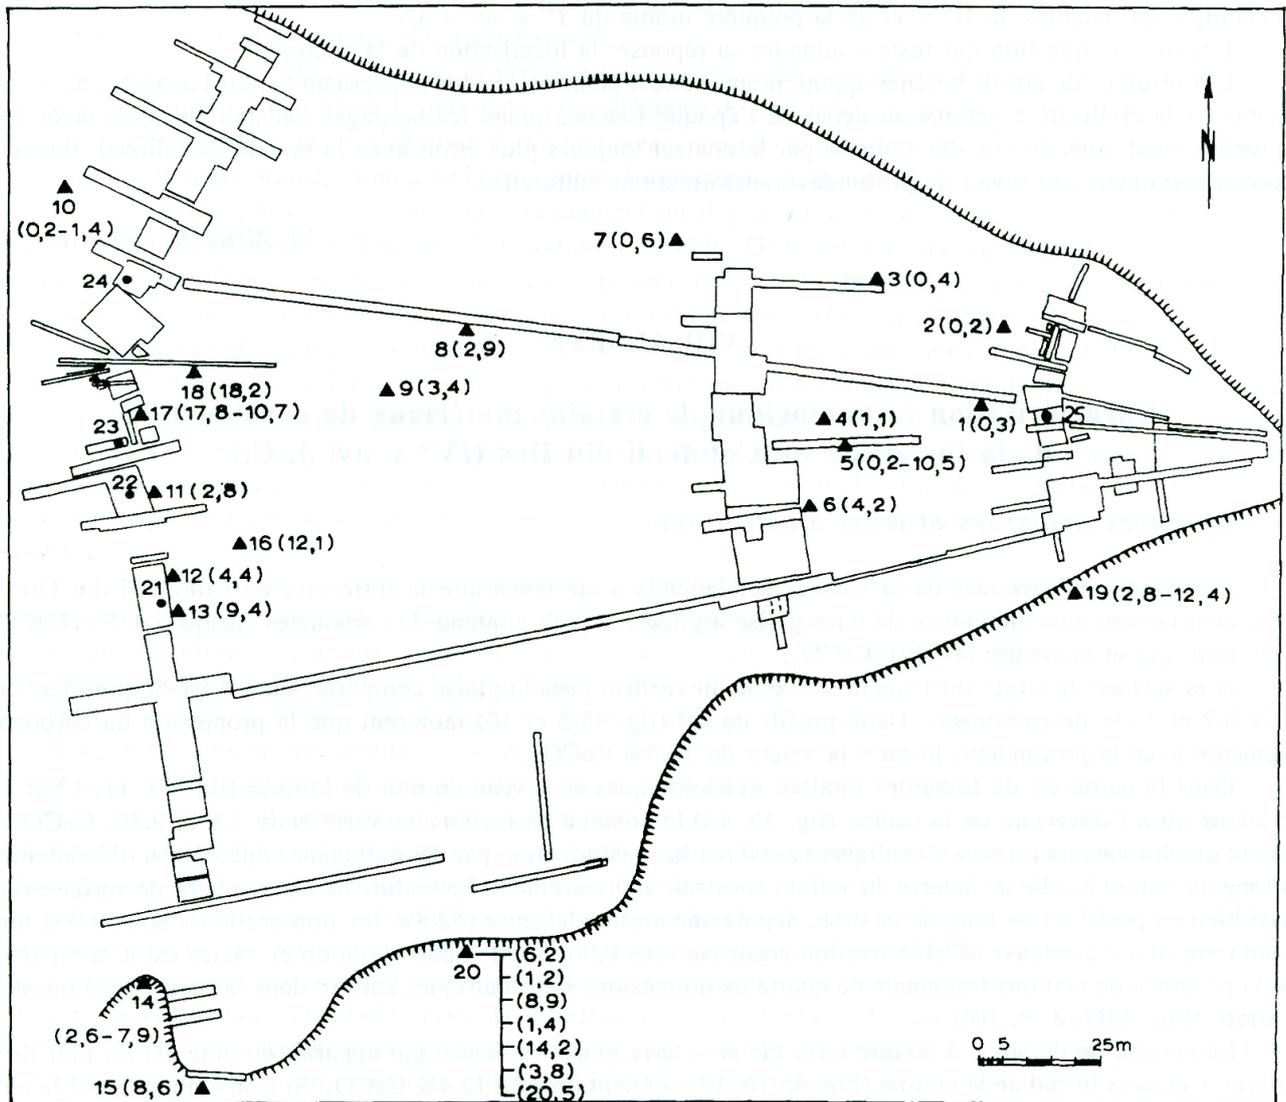
Figure 8. Collecting map of the lithological and archaeological samples at “Cetatea Jidovilor”, Coțofenii din Dos, Dolj county, Romania, after Gh. Găță, Caractérisation technologique de certains matériaux de construction de la forteresse de Coțofenii din Dos in VI. Zirra et alii, „La station gétiqie fortifiée de «Cetatea Jidovilor» (Coțofenii din Dos, dép. de Dolj)“, Dacia N.S. XXXVII, București 1993, 148, fig. 45.

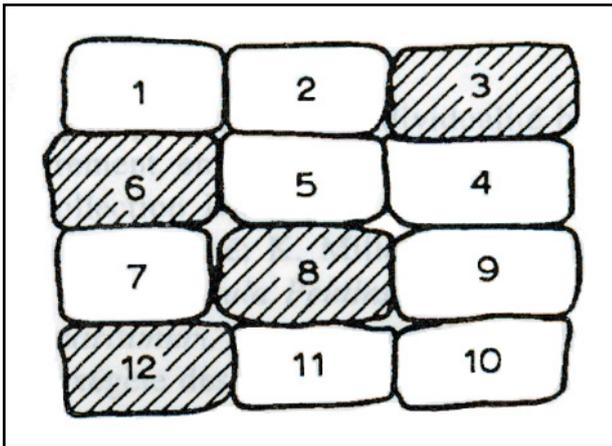
Figure 9. Sketch of an adobe bricks group from de Coțofenii din Dos fortification, B Surface, eastern parament. Samples 3, 6, 8, 12 are fired above 400-450^o C, and do not present the absorption band of infrared beams of 3697 cm⁻¹, after Gh. Gățã in Vl. Zirra et alii, „La station gétique fortifiée de «Cetatea Jidovilor» (Coțofenii din Dos, dép. de Dolj)“, *Dacia* N.S. XXXVII, București 1993, 157, fig. 54.

c. the combustion temperature analysis of a group of 12 adjacent brickwork (**Fig. 9**) revealed that there are significant variations in temperature between several such units superposed or juxtaposed;

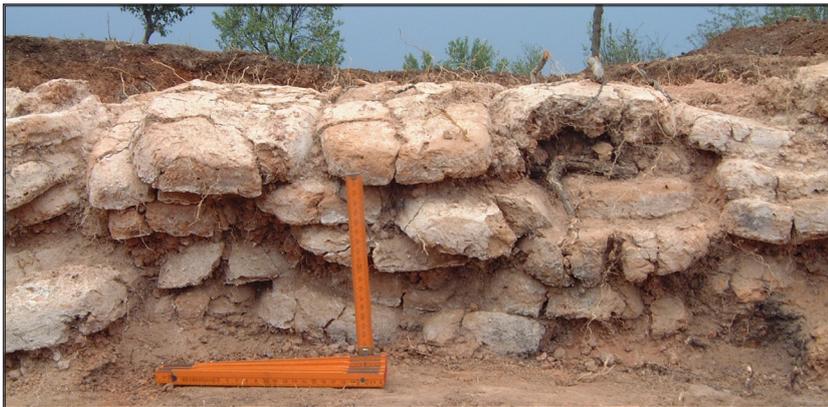
Figure 10: View of the interior burnt brick parament, (trench IX/2002). Sampling of the brick fragment and (emplecton) fired clay come from this spot.

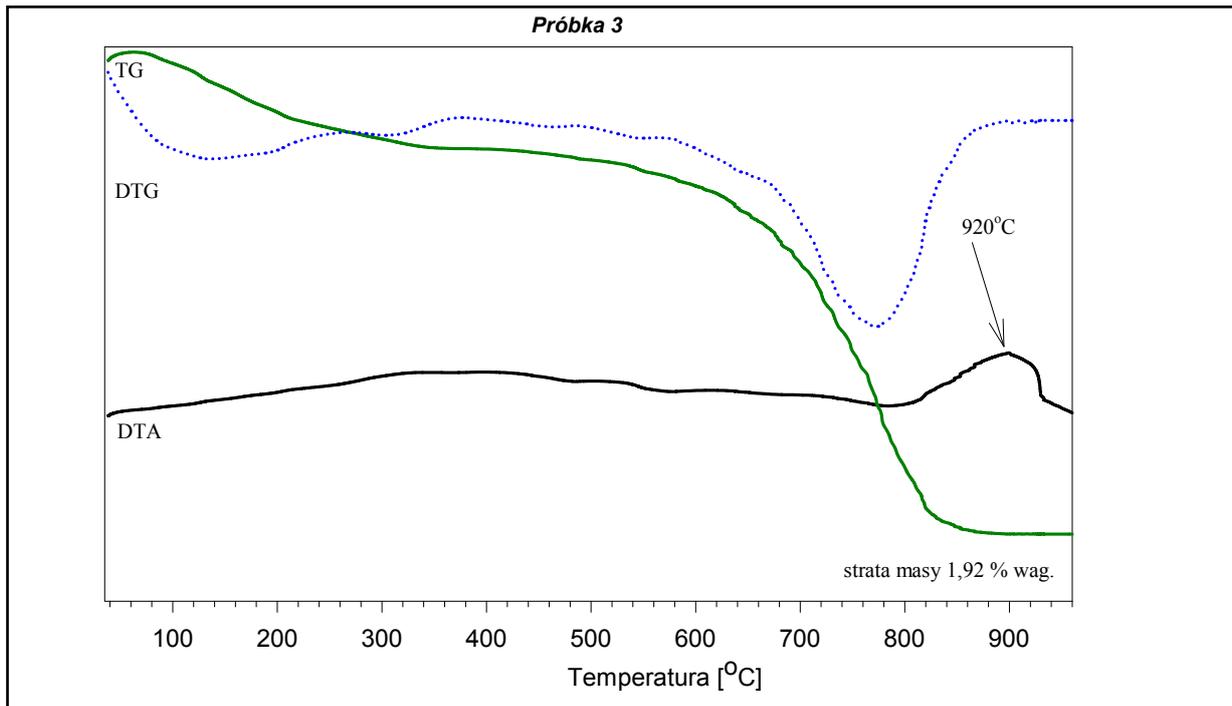
Figure 11. Thermogram of brick (sample 3), Bâzdâna-Calopăr, “La Cetate” fortified settlement, after H. Stoksik’s report.

Based on the derivatography analysis one may conclude that tested brick was exposed to temperature of 920° C (**Fig. 11**). Thermogram of the fired clay indicates a temperature of about 1050 °C (**Fig. 12**) that is significantly higher than the tested brick. Confirmation of that fact is the decreased porosity of the fired clay compared to porosity of the brick proved by the microscopic tests and lack of active phases in the fired clay at temperature about 1050° C in relation to the brick tested by derivatography method. Absence of thermal transformations of the feldspars in the fired clay proved by the microscopic and X-Ray analyses indicates however that tested clay was not a subject of heat treatment above 1100 °C”.

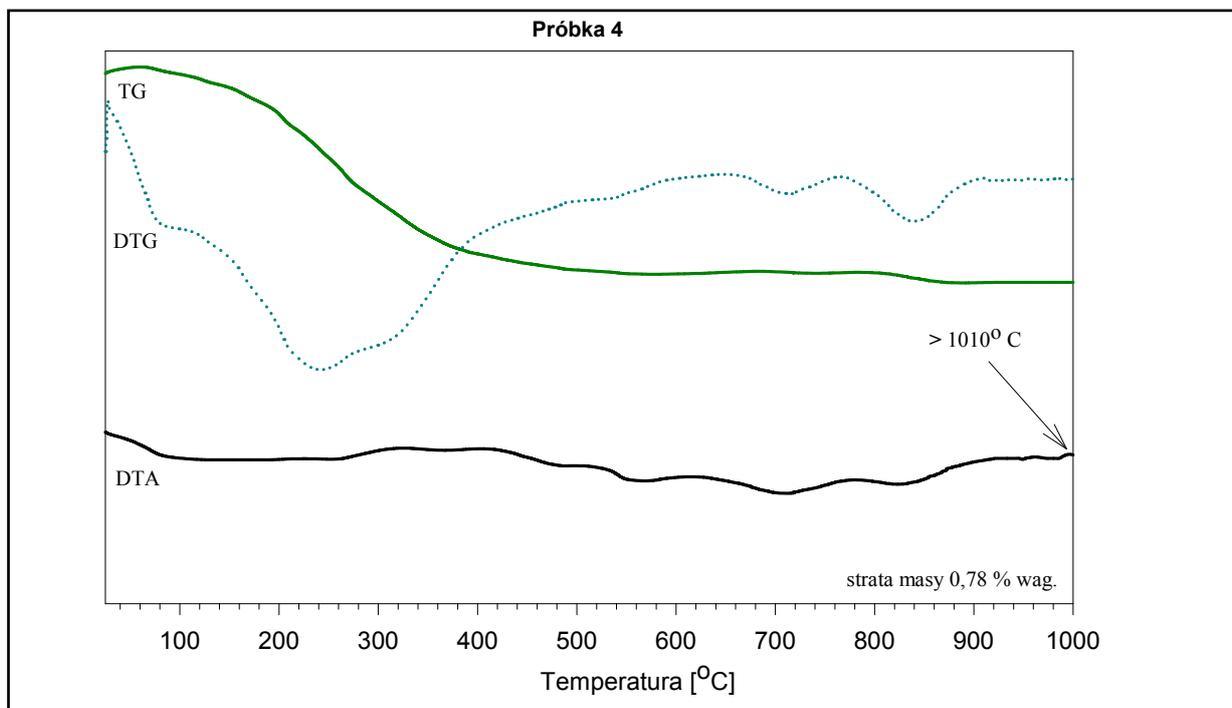
Figure 12. Thermogram of fired clay (sample 4), Bâzdâna-Calopăr, “La Cetate” fortified settlement, after H. Stoksik’s report.
