# Analysis of a metallic pedestrian bridge under dynamic human loads in pre and post reinforcement phases

Dora Foti, Salvador Ivorra, David Bru

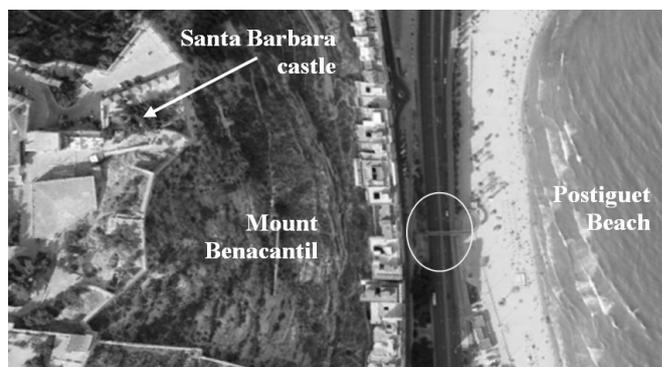
Fig. 1 Pedestrian bridge. Postiguet beach, Alicante, Spain.

The present paper analyzes the dynamic behavior of the steel footbridge of Postiguet Beach (Figs. 1-2) with the aim to mechanical characterize the structure in the pre- [22] and post-restoring state phases.

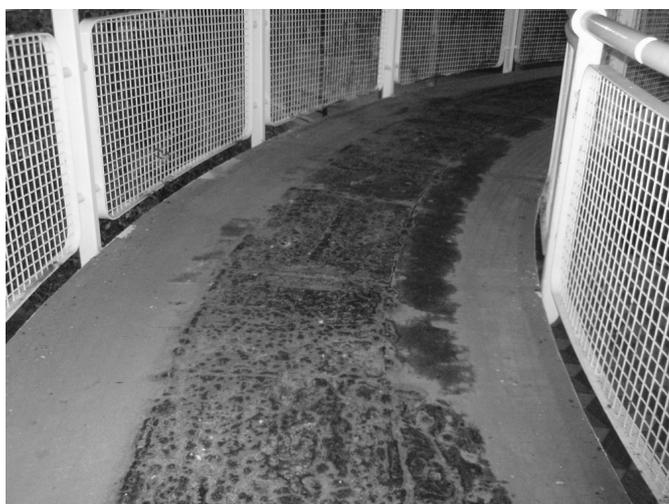
Fig. 3 Actual condition of the transversal section of the footbridge.

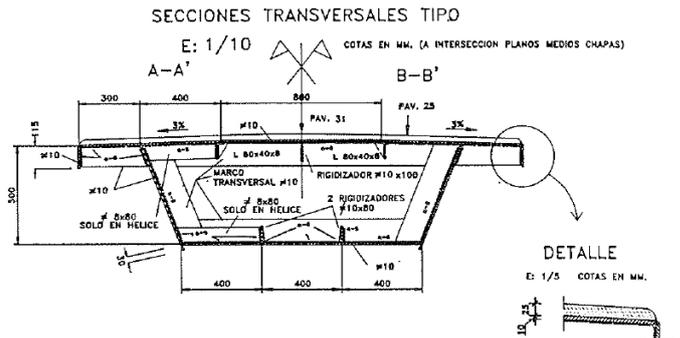
Fig. 4 Transversal box section [Original design in Spanish].

The intermediate supports are five simple supports, aligned to the deck, with a metallic circular hollow section of A52 steel ( $f_u=520 \text{ N/mm}^2$ ), connected to the beam through supports in confined neoprene. The foundation of the deck closest to Mount Benacantil (see Fig. 1) has a fixed joint made with 8  $\phi 32$  DYWIDAG 85/105 steel bars with a length of 12.5 m. Similarly, on the side next to the beach, at the first support, the fixed joint is obtained with GEWI  $\phi 32$  AEH500N steel bars (Fig. 4) ( $f_u=500 \text{ N/mm}^2$ ).

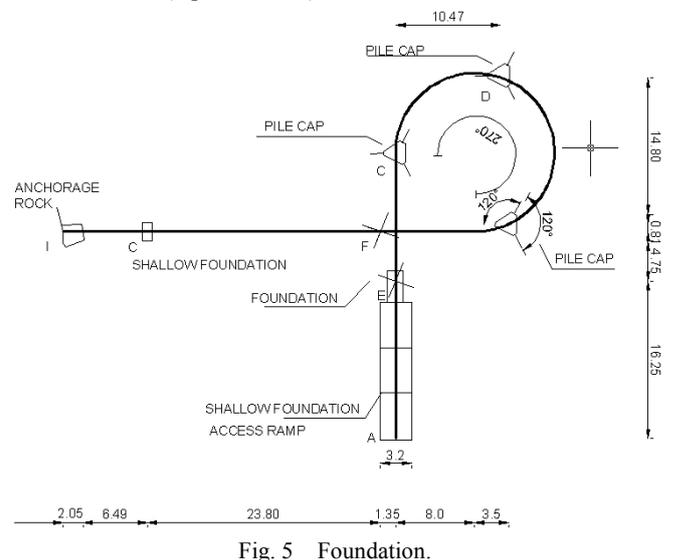
The structure is divided into 6 spans of 8.5 +24 +13 +19 +15 +12 m length (Fig. 5) and it is fixed at both ends, with the rotation around the vertical axis blocked. A static scheme of a continuous beam on supports has been assumed for the deck. The cross section of the walkway has a constant height of 0.5 m, thus resulting in a significant slenderness (height/span ratio) of the structure (equal to 1/48).

Fig. 5 Foundation.

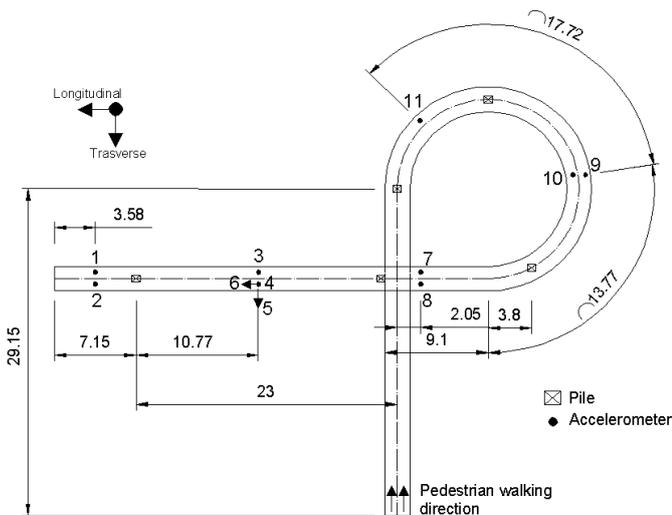
Fig. 6 Positioning of the accelerometers: (a) plan section, (b) transversal section of the footbridge.

To obtain the damping factor associated to the main bending mode, free vibration tests after the excitation of a pulse load were performed. The pulse load consisted in a concentrated load applied at the points of the footbridge associated with the excited mode where the damping factor had to be determined. A load equal to 1.8 kN was applied in points 3 and 9 (Fig. 6).

Moreover, also after the upgrade another dynamic load test has been performed. A group of six pedestrians of about 5 kN of total weight was used as a source of excitement for the test. Pedestrians crossed the footbridge in the same direction as in the pre-retrofit tests at 90, 135 and 198 steps/min. Fig. 16 shows the group of the six pedestrians at 90 steps/min. The location of the accelerometers was the same as in the preceding test (Fig. 6).

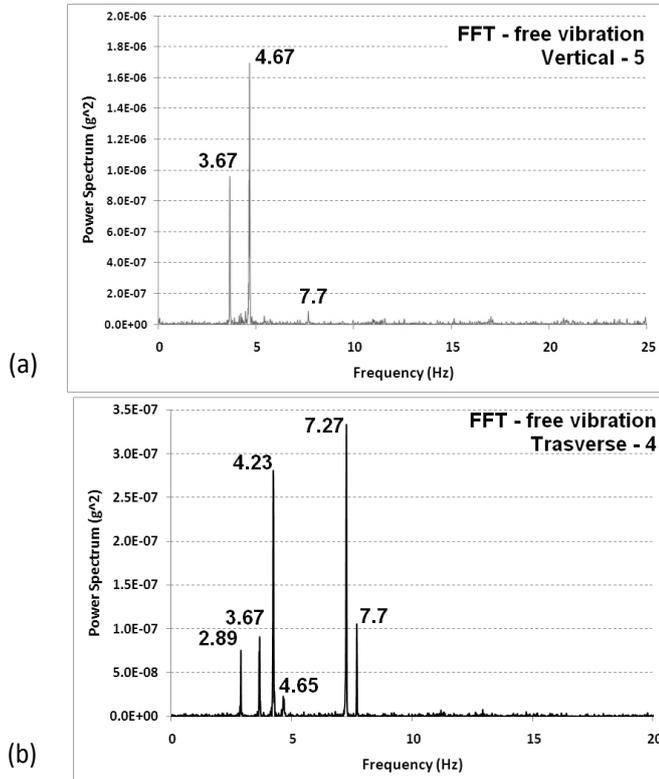
Fig. 7 Natural frequencies from the FFT analysis in free vibration. a) Accel. n° 5. b) Accel. n° 4.

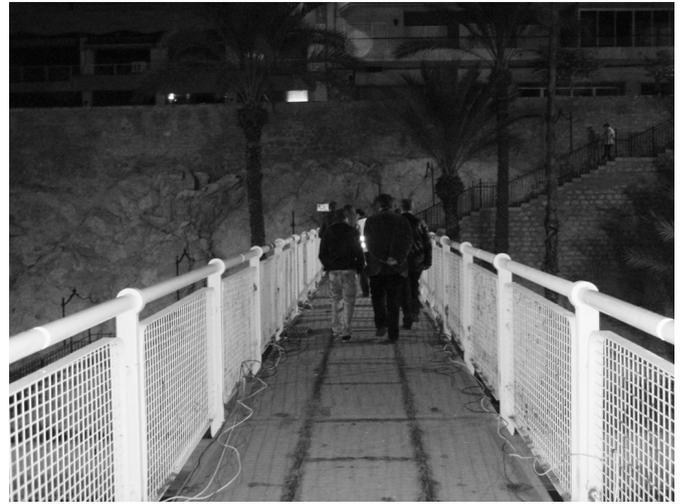
With this aim, two scenarios have been defined. The first corresponds to the transit of a group of nine persons arranged in 3 rows, with a total weight of 6.18 kN, moving along the whole structure at different speeds (90 steps/min, 135 steps/min and 198 steps/min [3],[7]) (Fig. 8). The induced accelerations were recorded in points 1-8, at a sampling frequency of 200 Hz. The second scenario was to evaluate the effect of the cantilever balcony beam in the curve area of the walkway, under the influence of a person jumping in a central position of the cross section at a frequency of 135 steps/min. The values of acceleration were recorded. For a proper

Fig. 8 Test on the footbridge. Disposition of the pedestrian stream.

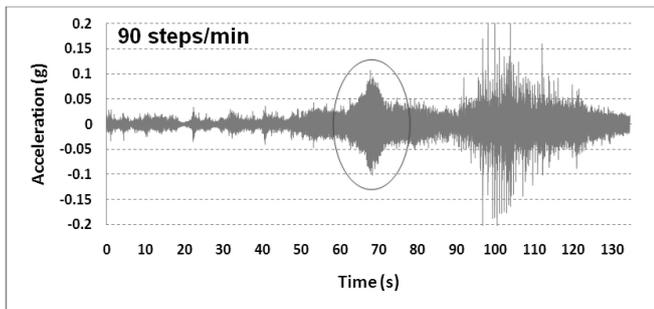
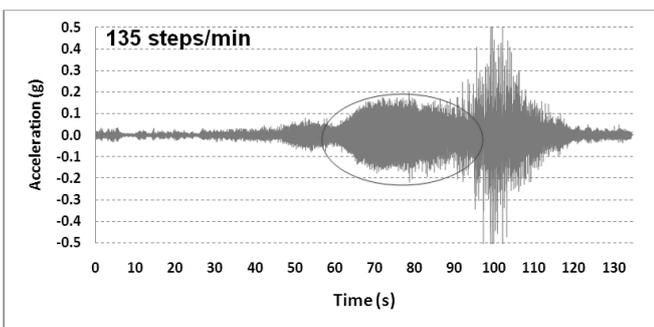
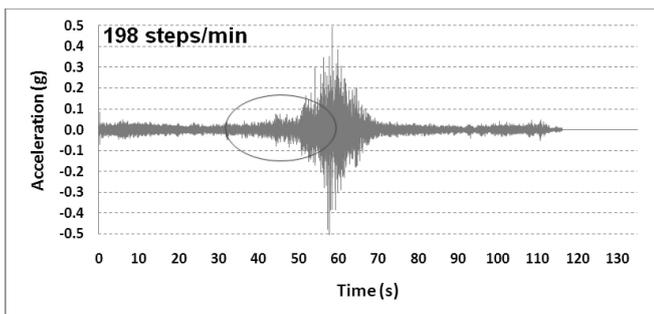
Fig. 9 Effect of the resonance at the pedestrian step in the central part. Accelerometer 3. a) 90 steps/min; b) 135 steps/min; c) 198 steps/min.

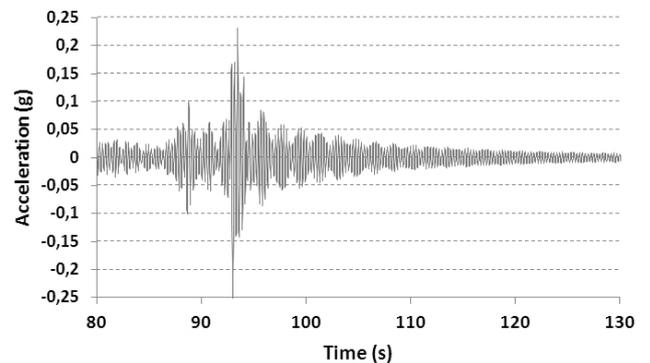
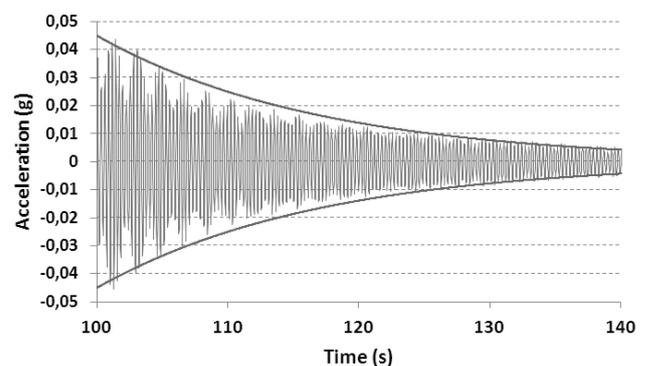
Fig. 10 (a) Time history response after an impact load on the deck. (b) Decav curve to evaluate the damping ratio.

Response of accelerometer number 4 was filtered between 3 and 4 Hz; the damping factor for the first two vertical vibration modes (3.64 Hz, 4.64 Hz) is then obtained by the technique of the logarithmic decrement from the damped curve after the excitation phase, obtaining a value equal to 2.03% (Figs 10a and 10b).

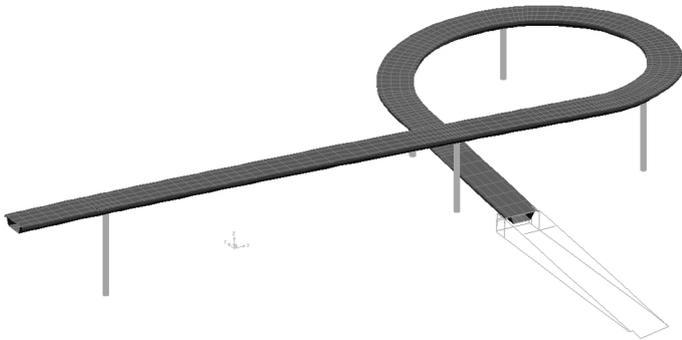
The finite element model used to study the dynamic effects produced by pedestrians on the footbridge was modeled with SAP2000 software [15], discretizing the structure into a 3D model composed of shell elements for the deck and for the columns (Fig. 11).

Fig. 11 Numerical model with SAP2000.

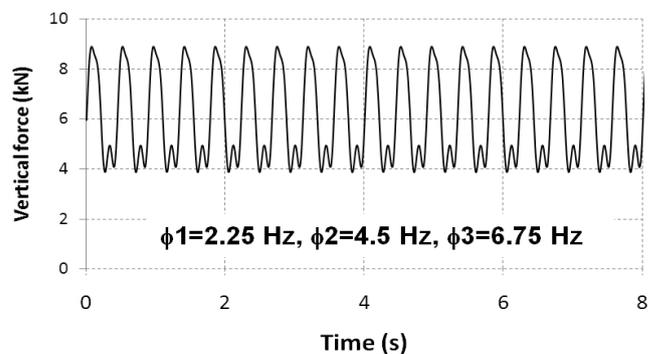
To analyze the worst situation experimentally recorded a vertical load generated by the nine pedestrians who walk at speeds of 135 steps/min and 198 steps/min was simulated, resulting in a time-history for a variable load distributed over 4 nodes in the area in curve of the walkway for 10 s (Fig. 13). Following the recommendations of Bachmann [3], three

Fig. 13 Time history plot of the vertical force generated by pedestrians at 135 steps/min speed.

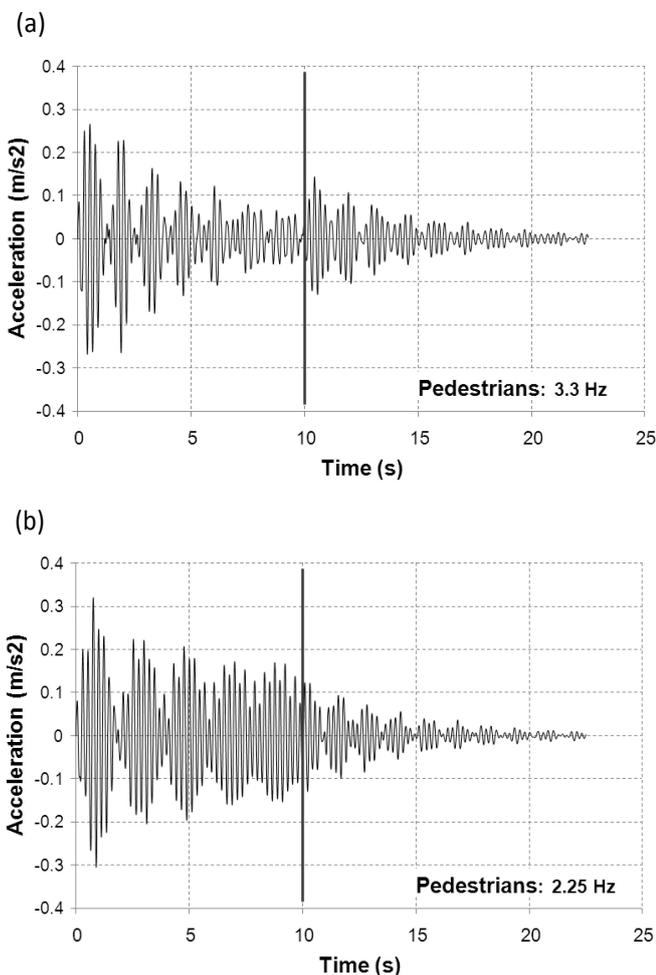
With the aim to justify the dynamic interaction of pedestrians at 135 steps/min (harmonics 2.25 Hz, 4.5 Hz, 6.75 Hz) compared to the passage at 198 steps/min (harmonics 3.3 Hz, 6.6 Hz and 9.9 Hz), Figures 14a and 14b show the time-history of the maximum vertical accelerations recorded in the central part of the straight section of the walkway when the pedestrians pass in the curved area for 10 s. Even though the applied load is higher for the case of 198 steps/min (Fig. 14a), in these plots it can be noticed how the time-history in the middle of the central part shows much higher values for pedestrians at 135 steps/min. The accelerations recorded in this last case were almost twice as much. In the plots of Figure 13, from 10 seconds onwards, the time load introduced in the curved area is removed and the central part tends to fade.

Fig. 14 Time-history of the vertical displacement in the central area of the straight section of the footbridge when pedestrians are in the curved area at a speed of a) 198 steps/min , b) 135 steps/min.

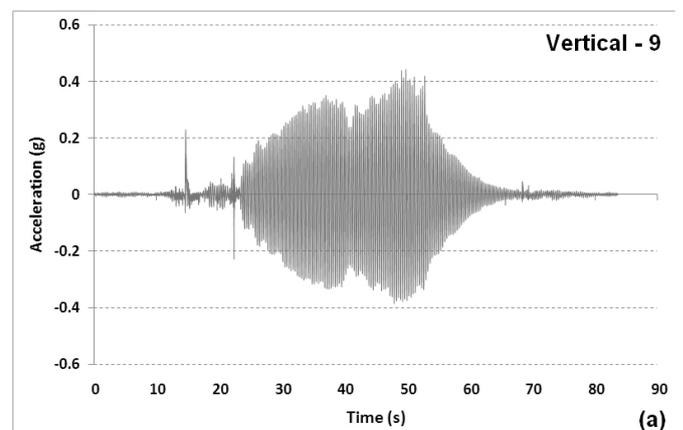
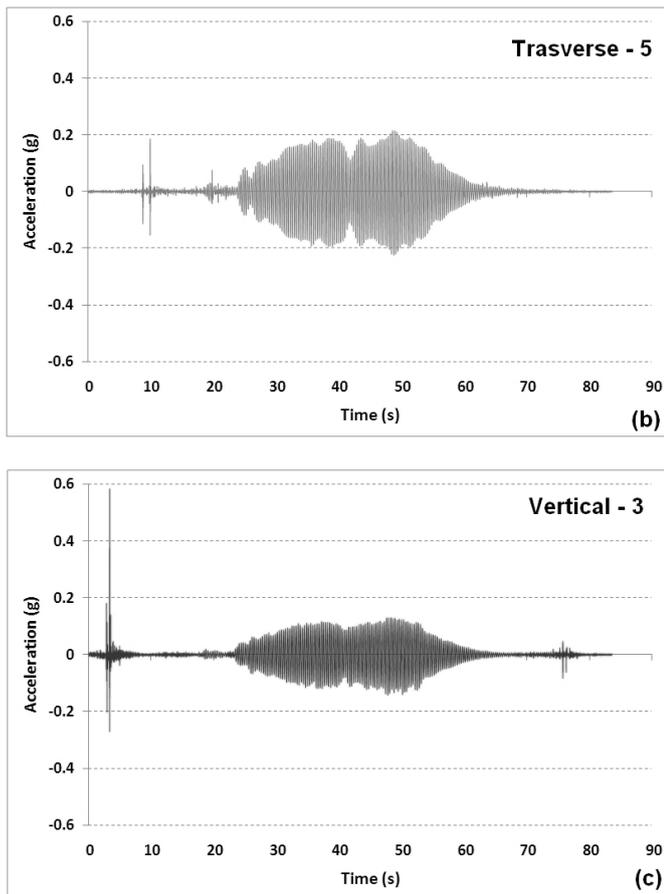
In order to determine the new structural damping factors the footbridge has been excited by two pedestrians located at the position of accelerometer 9, at an excitation frequency of 198 steps/min for 30 s (Fig. 15). From the plots of free vibrations generated by this excitement using the logarithmic decrement procedure, and filtering it between 3 and 4 Hz, a value around 4% for the damping factor is obtained. Moreover, during the tests it was observed that damping is a nonlinear characteristic of the structure very dependent of the introduced load.

Fig. 15 Response at a force excitation in position 9. a) values recorded in 9

Fig. 15 Response at a force excitation in position 9 b) values recorded in 5 – transversal; c) values recorded in 3 – vertical.

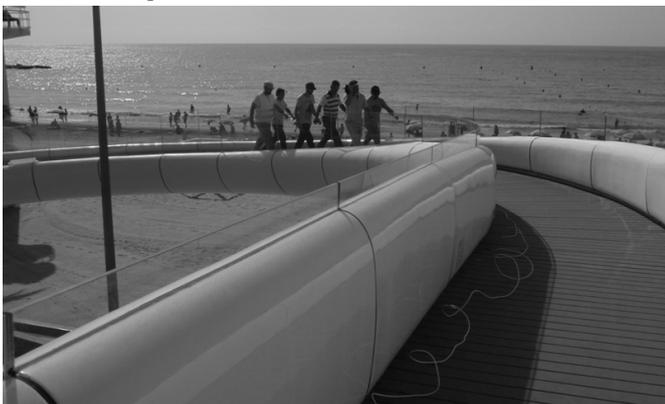
Fig. 16 Group of 6 pedestrians walking on the footbridge

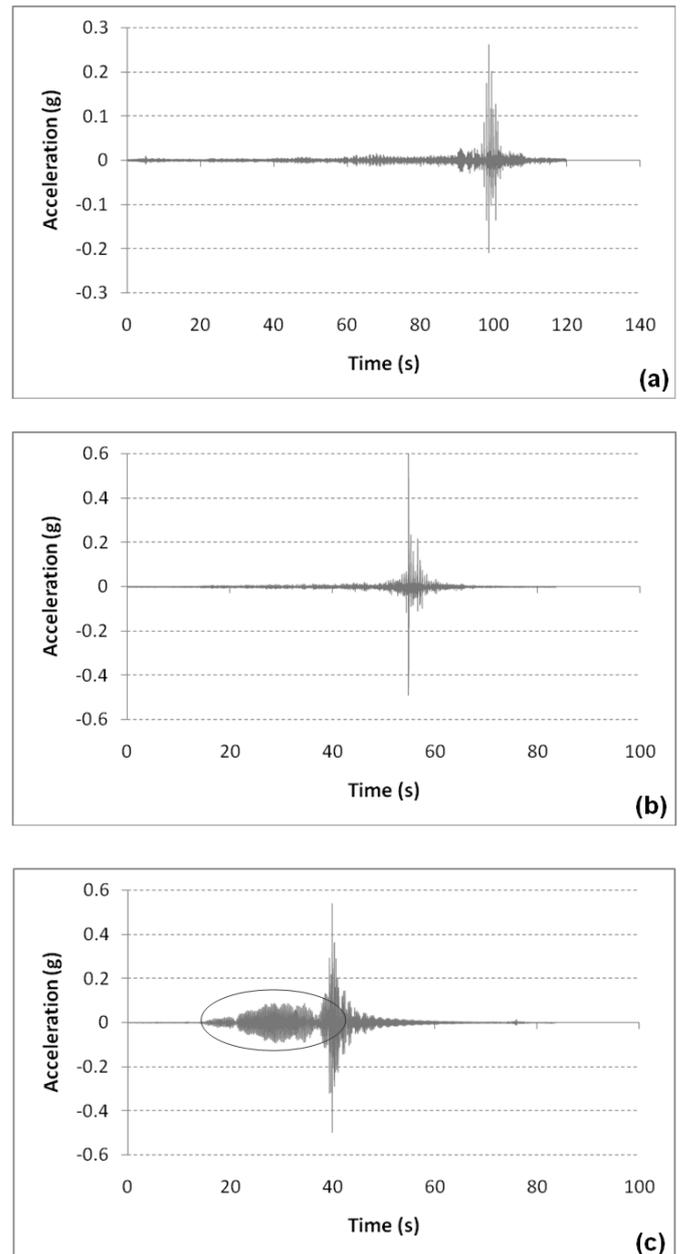
un-restored footbridge. Fig. 17 shows the temporal variation of the vertical accelerations at position 3. This figure shows that resonance phenomena occurred for a speed of 198 steps/min. In fact, when the pedestrians pass on the area in curve at this frequency, the center of the straight span was vertically excited (Figure 16c). In all cases when pedestrians passed next to accelerometer 3, the levels of acceleration showed specific peaks.

Fig. 17 Vertical accelerations at a) 90 steps/min, b) 135 steps/min and c) 198 steps/min recorded at accelerometer 3

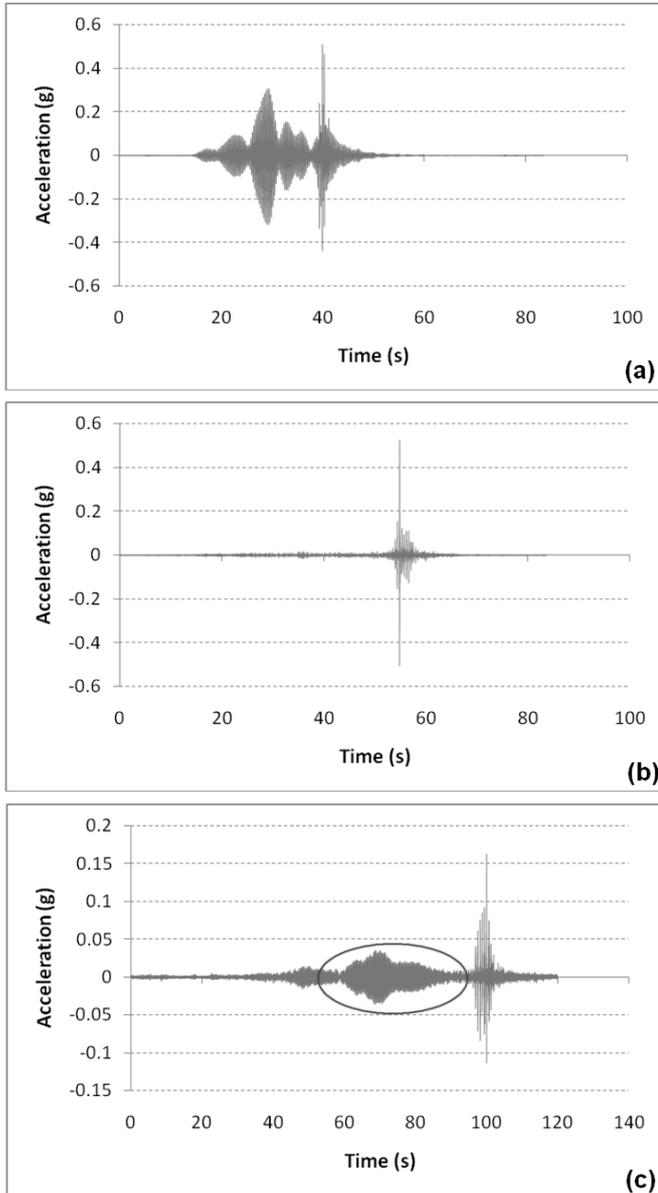
Regarding the plots in Fig. 18, it has been noticed that the horizontal response of the footbridge was influenced by the excitement generated by pedestrians. Fig. 18 shows the temporal variation of the transverse accelerations recorded at accelerometer 5. Figs. 18a and 18c show a significant

dynamic interaction between the excitation frequencies and modes of lateral vibration of the walkway itself. The passage of pedestrians in the area of the cantilever - position 9 - generates a significant lateral acceleration at the center of the bay located at position 5.

Fig. 18 Transversal accelerations at a) 90 steps/min, b) 135 steps/min and c) 198 steps/min, recorded in position 5

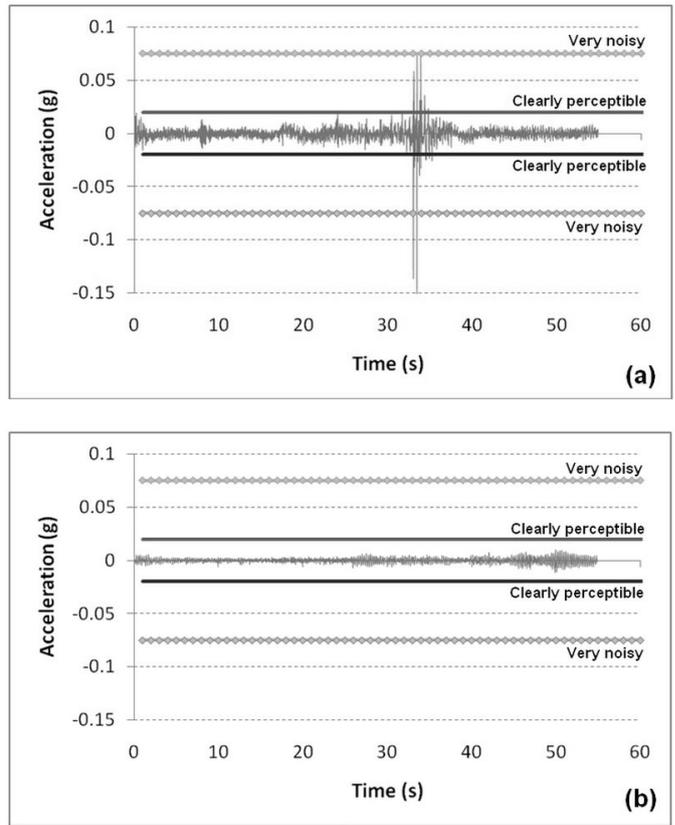
Fig. 19 A person of 110 kg of weight walking on the runway at 135 steps/min. The plots also report the limits of acceptability following the Spanish code (0.025g). a) Accelerometer 7 located on the cantilever. b) Accelerometer 4 located in the center span, vertical.
