About the Structural Restoration of the S. Domenico's Monastery in Naples

O. Corbi and M. Candela

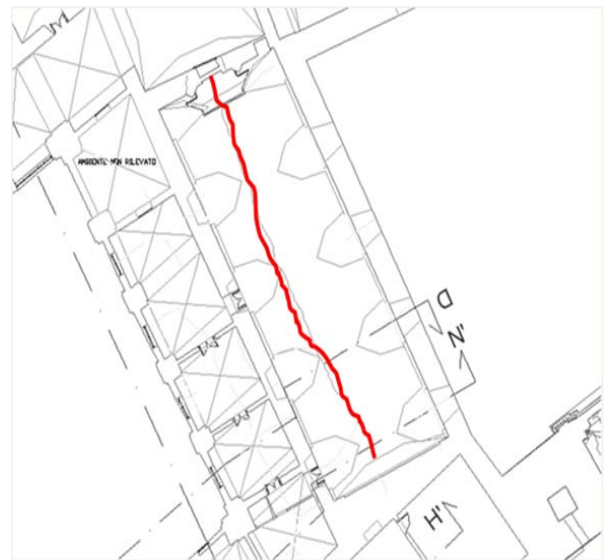
Fig. 5 - The Chapter Hall plan with the main crack in the key; one may notice the resistant panels facing the main cloister with a free length of about 40 m.

The representation of the crack pattern of the chapter hall is shown in Figs 4 and 5.

One traced one of the causes of instability in the absence, for over 38 mt, of transverse diaphragms, resulting in noticeable deformations of the longitudinal walls.

From Fig. 5 the crack distributions are detected with fractures localized along the lunettes of the barrel vaults; those appear rigidly lifted up, especially on the side that faces the cloister; one may notice a large crack as well as present along the South side of the chapter hall.

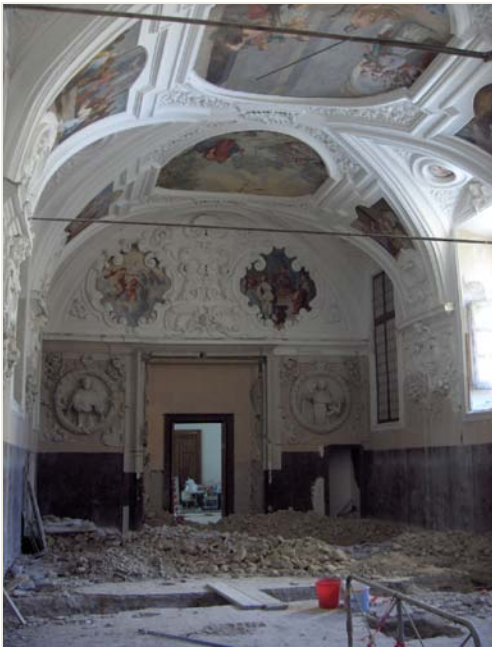
Fig. 6 - The Chapter Hall consolidated vault with the metallic tie-rods during the restoration works.

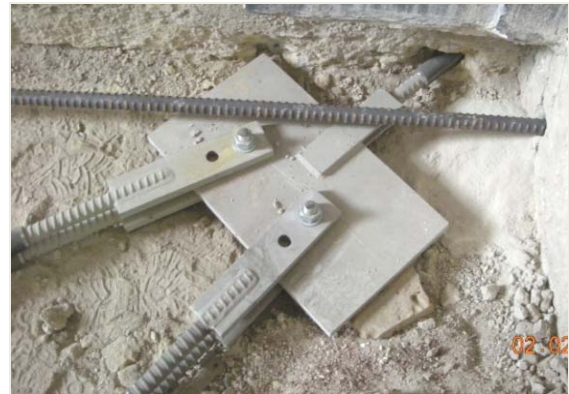
Fig. 11 - Detail of the anchoring plates.

Particular attention was paid to follow the construction work, in order to prevent that small defects, such as excesses of mortar in the anchoring plates, reduce the effectiveness of the intervention; its tensioning was verified by means of shooting tests with values proportional to the maximum ones predictable under operation service of up to 43,000 dN, which demanded the design of special plates with size of 60 x 120 cm and with three bolts (see Figs 10 and 11).
