# Technical Aspects on a Landslide Affected Construction

Andreea-Terezia Mircea

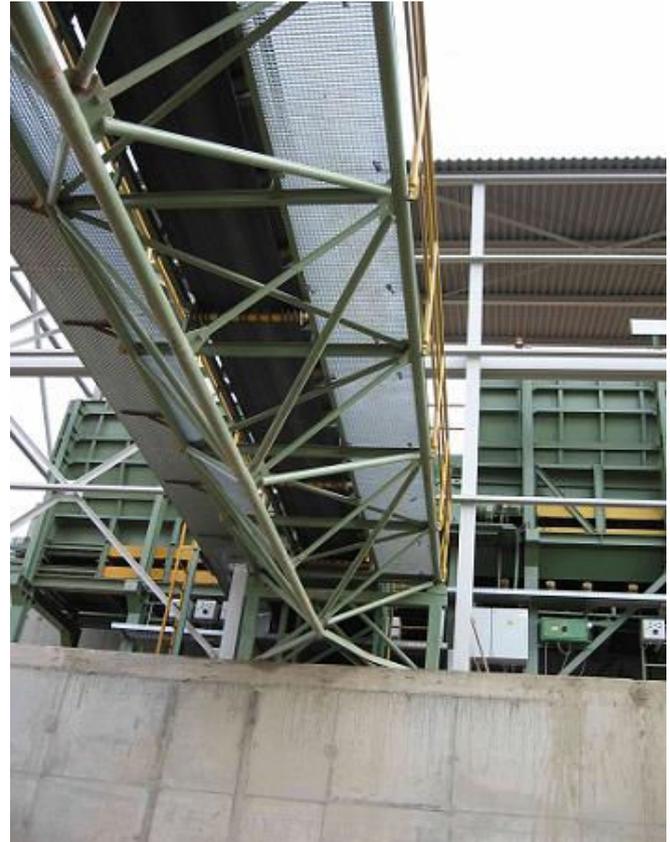
The investigated construction object was built on reinforced concrete elastic foundation base with monolith reinforced concrete walls [6]. The box structure consists of monolithic diaphragms with a thickness of 30 cm (on the exterior transversal axes 1 and 5, respectively on the axis A) located on the open perimeter, and with a thickness of 25 cm on the inside (on the horizontal axis 2 – 4, and on the longitudinal axis B, above the level +3.20). The slabs are made also from monolith concrete, having a thickness of 30 cm. The inside of the concrete box is filled with earth filling.

Fig. 7 The box feeder built on reinforced concrete foundation
